Capital City Development Corporation

Central Bench Study Area

Urban Renewal Area Eligibility Report

April 8, 2019

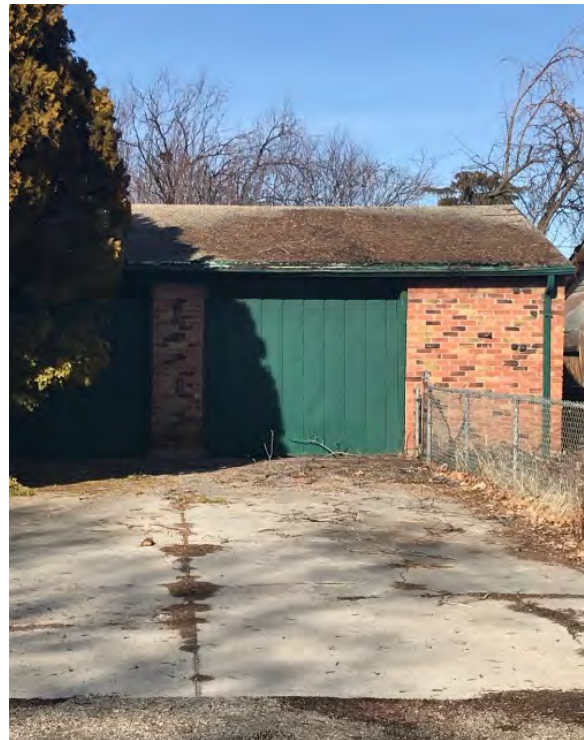
Deterioration of roof on West Clinton Street.

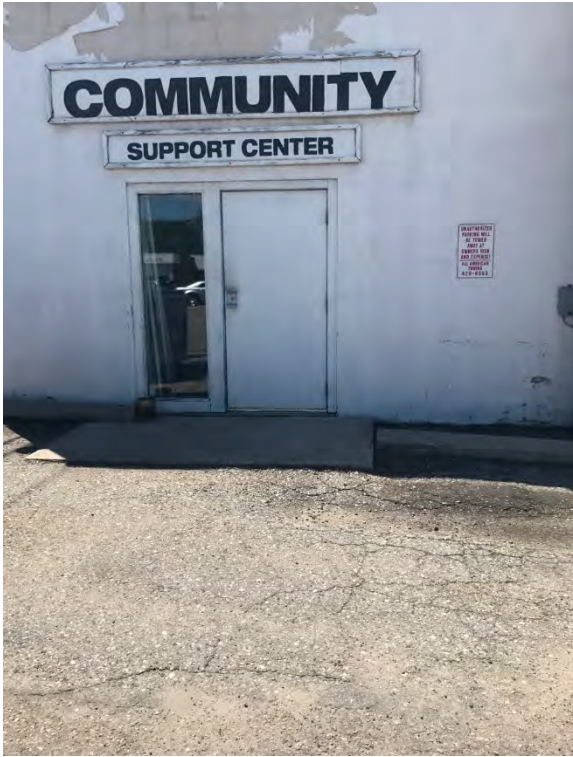
Deterioration to exterior and parking lot on North Orchard Street

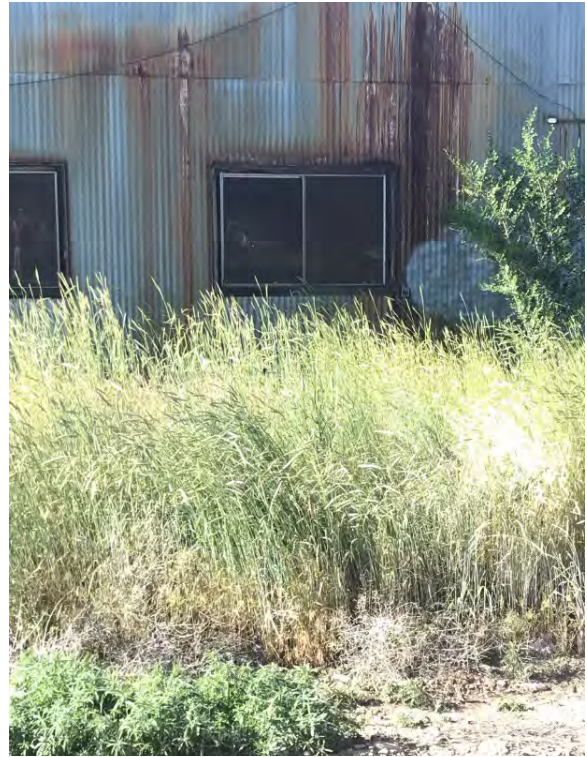
Rusting corrugated metal exterior and overgrown vegetation along North Curtis Road

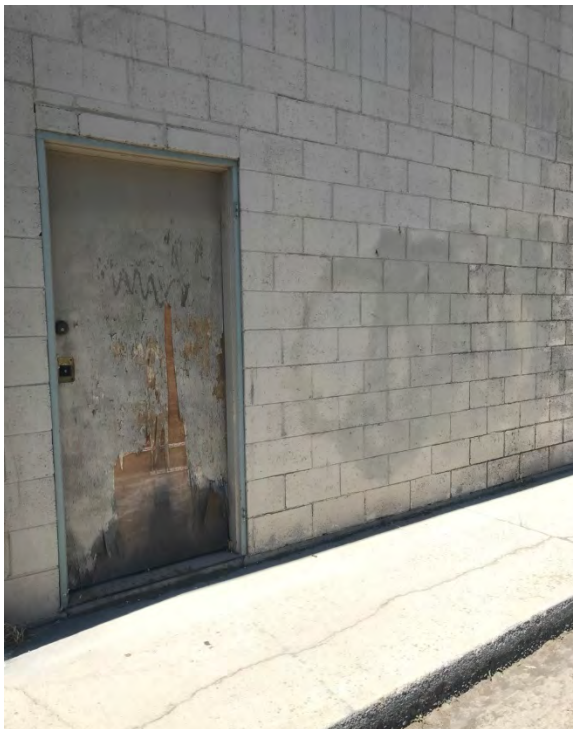
Signs of neglect and vandalism on West Emerald Street.

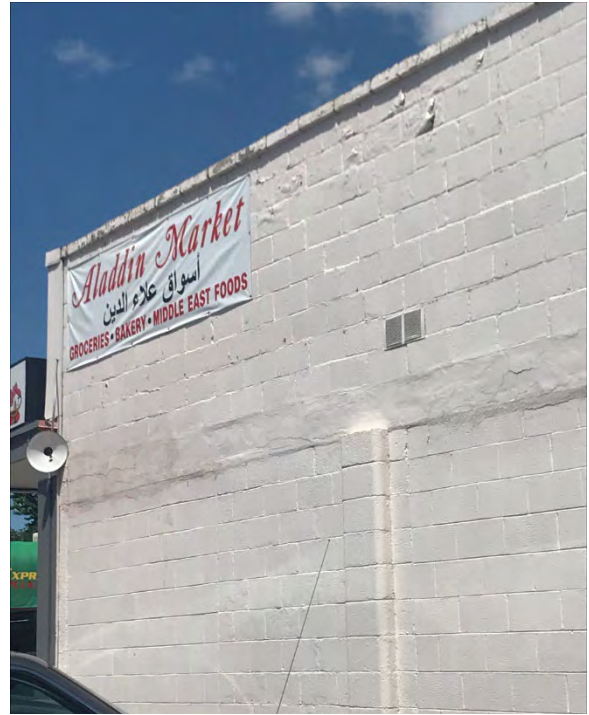
Evidence of water damage along roofline along North Orchard Street

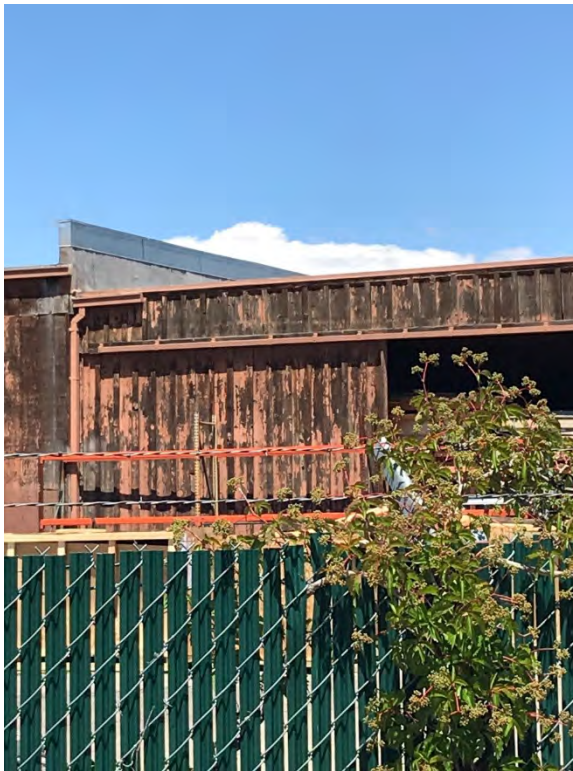
Dilapidated exterior on North Orchard Street

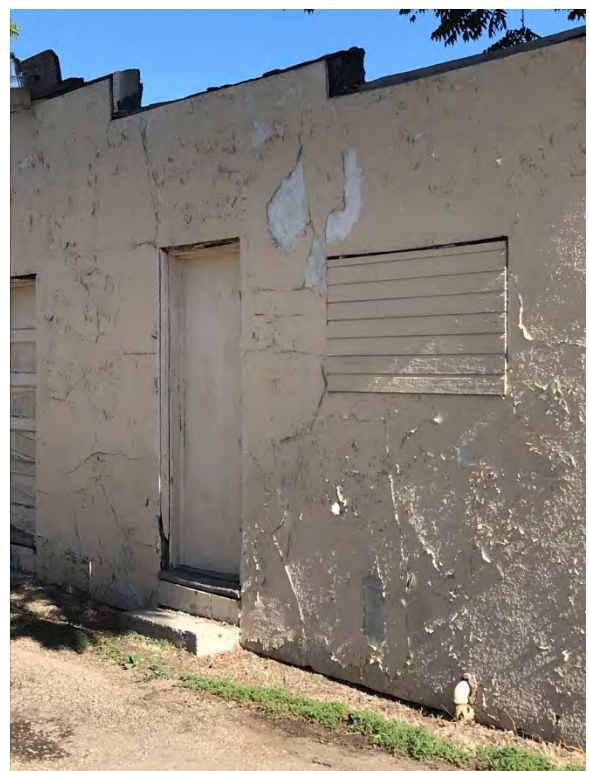
Deteriorating exterior, doorway, and boarded-up windows on West Fairview Avenue.

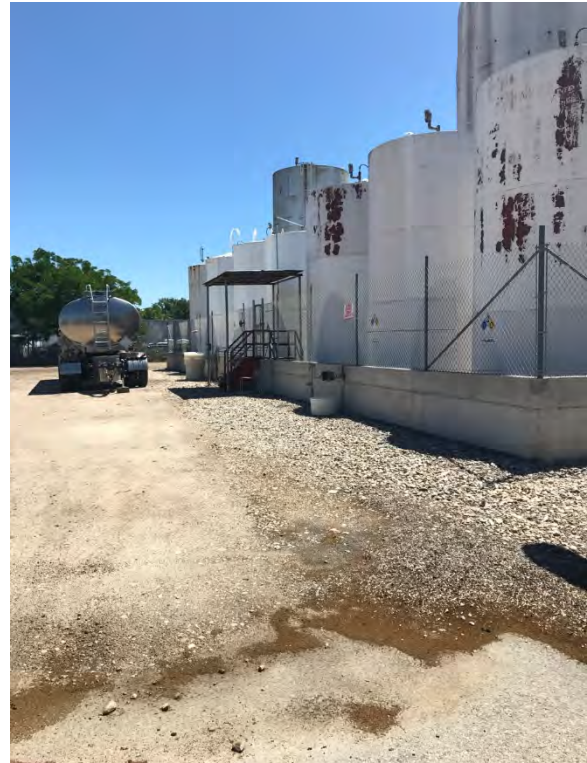
Site deterioration and erosion on North Phillippi Street

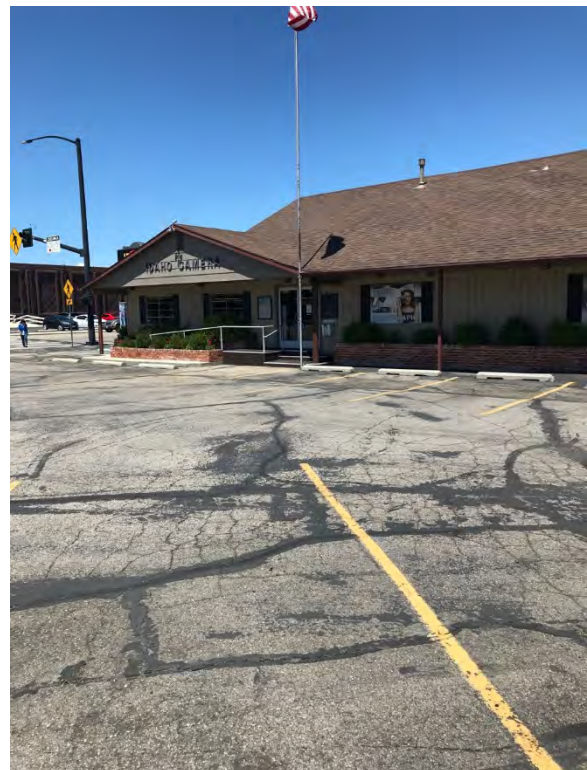
Extensively cracked parking lot on North Orchard Street

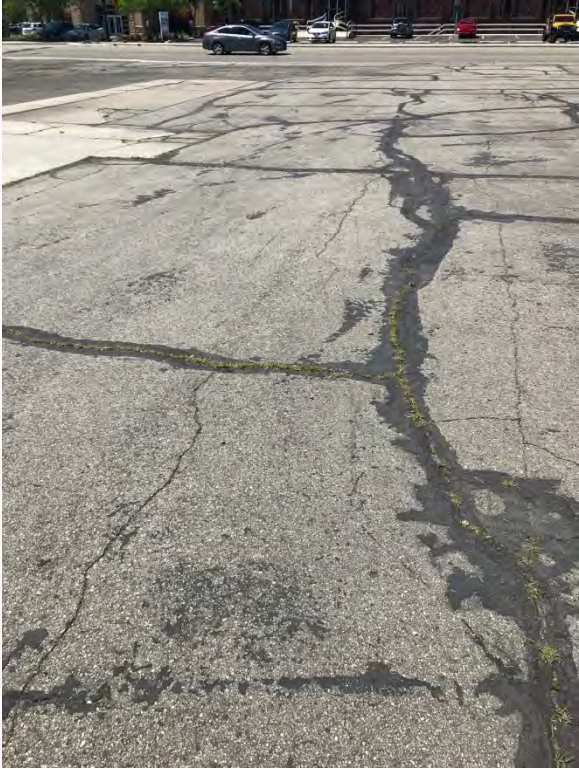
Site deterioration on North Orchard Street

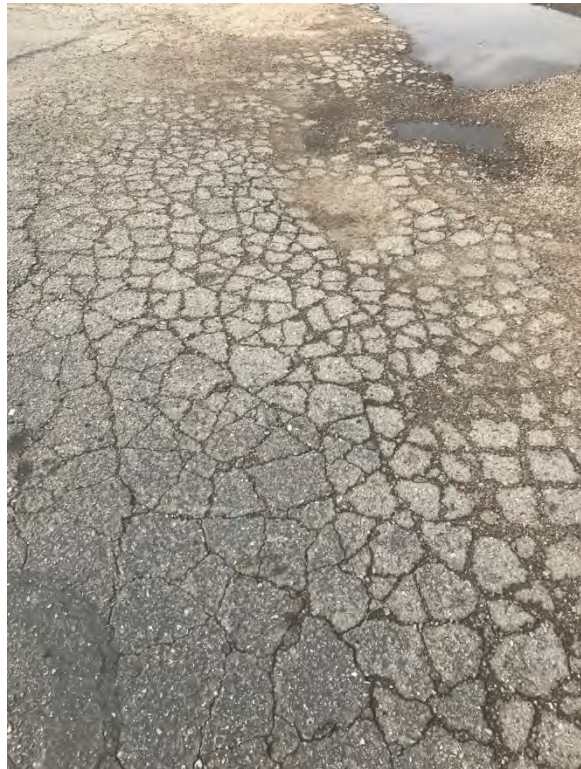
Site deterioration on North Curtis Road

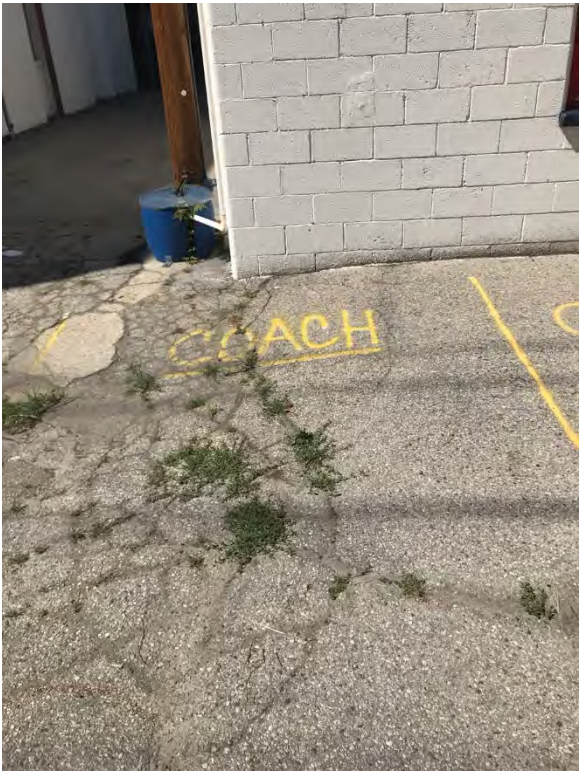
Deterioration of parking lot on West Franklin

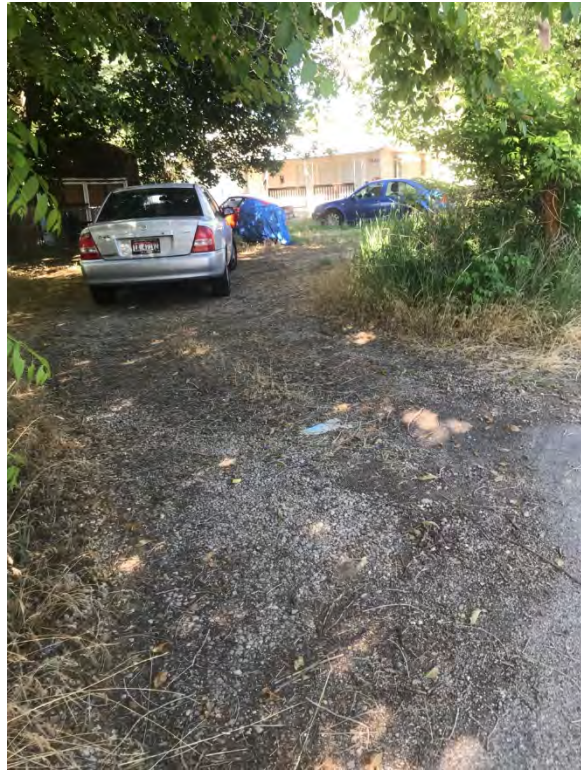
Site deterioration and overgrown vegetation on West Richardson Street

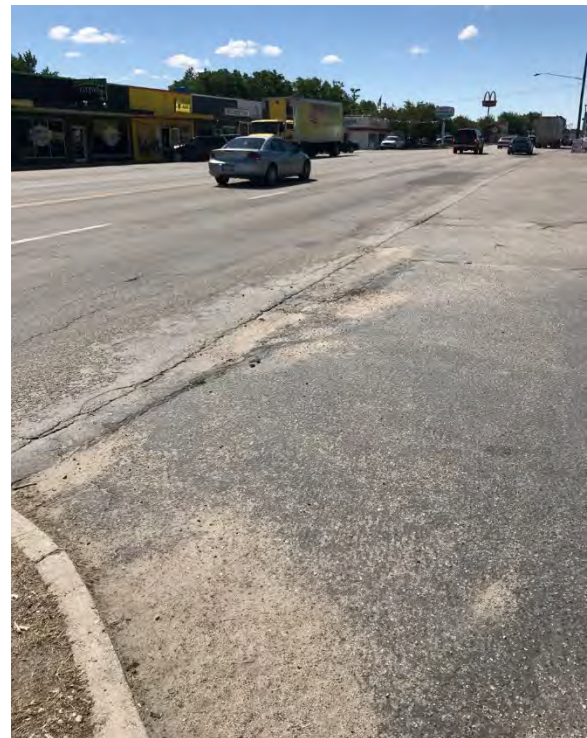
North Orchard Street looking south from near Fairmont Street. Visible in the foreground is the parking lot entrance of 601-615 North Orchard Street. This parcel and the parcel across the street at 602-620 North Orchard Street utilize pull-in angled parking, which is unsafe for motorists and pedestrians, especially along major streets such as North Orchard.

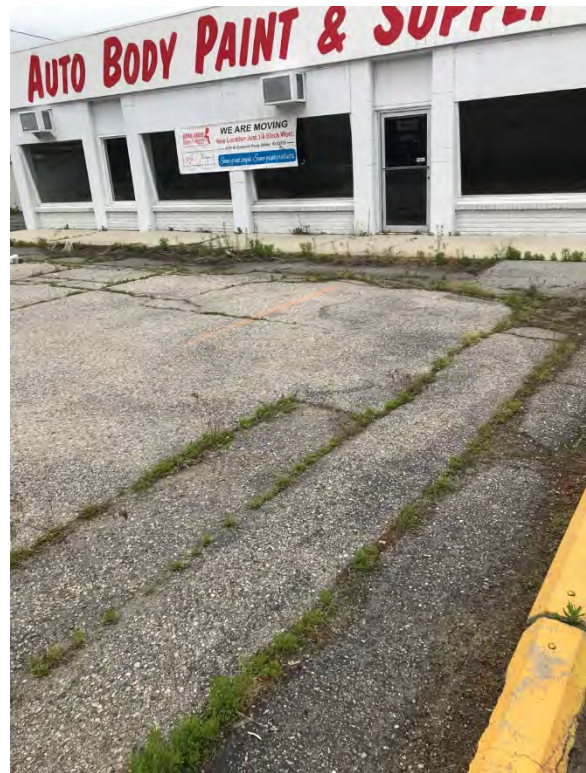
Vacant and obsolete brick and cement block structure with deteriorated site conditions on West Overland Road.

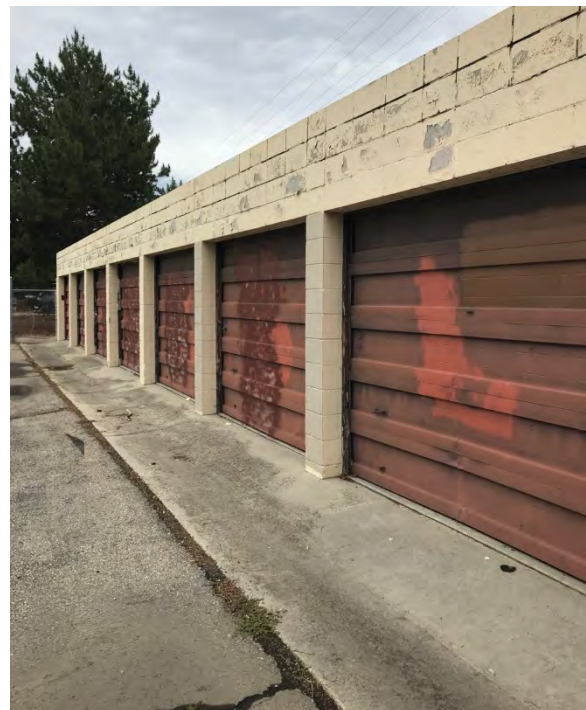
Deterioration of cement block building on West Overland Road

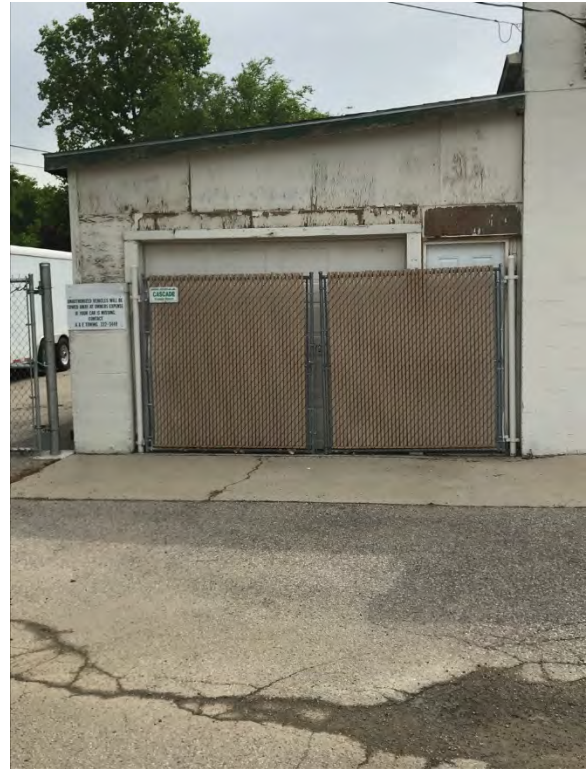
Deteriorating building exterior on West Overland Road

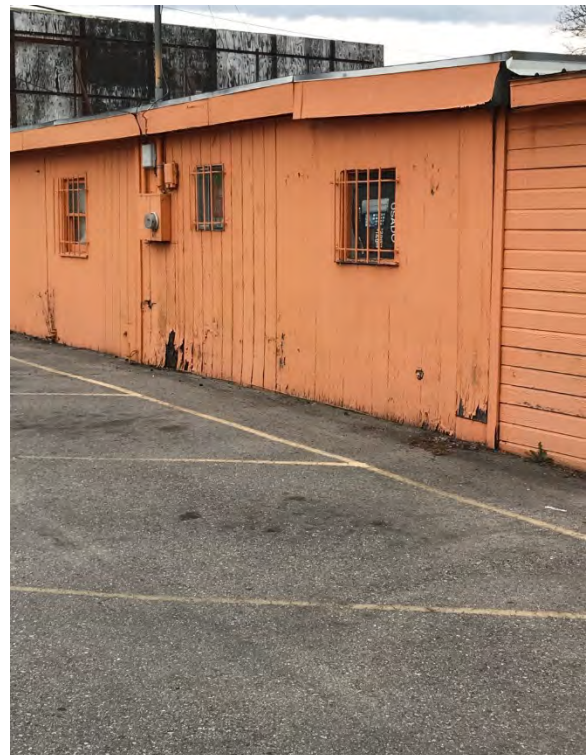
Deteriorating building on South Orchard Street

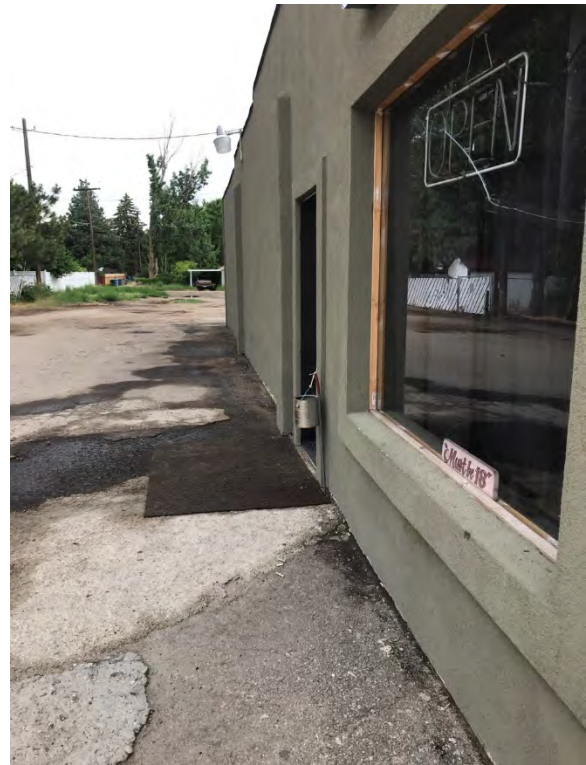
Cracked and deteriorated parking lot on West Overland Road

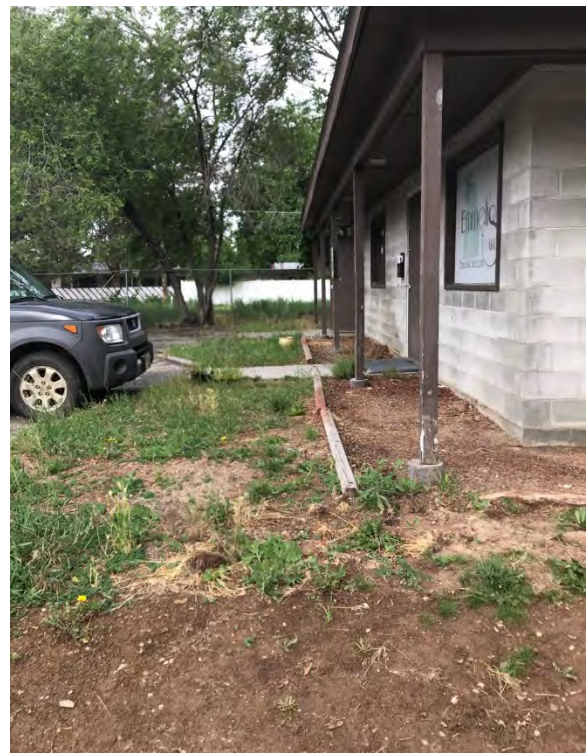
Signs of site neglect along West Overland Road

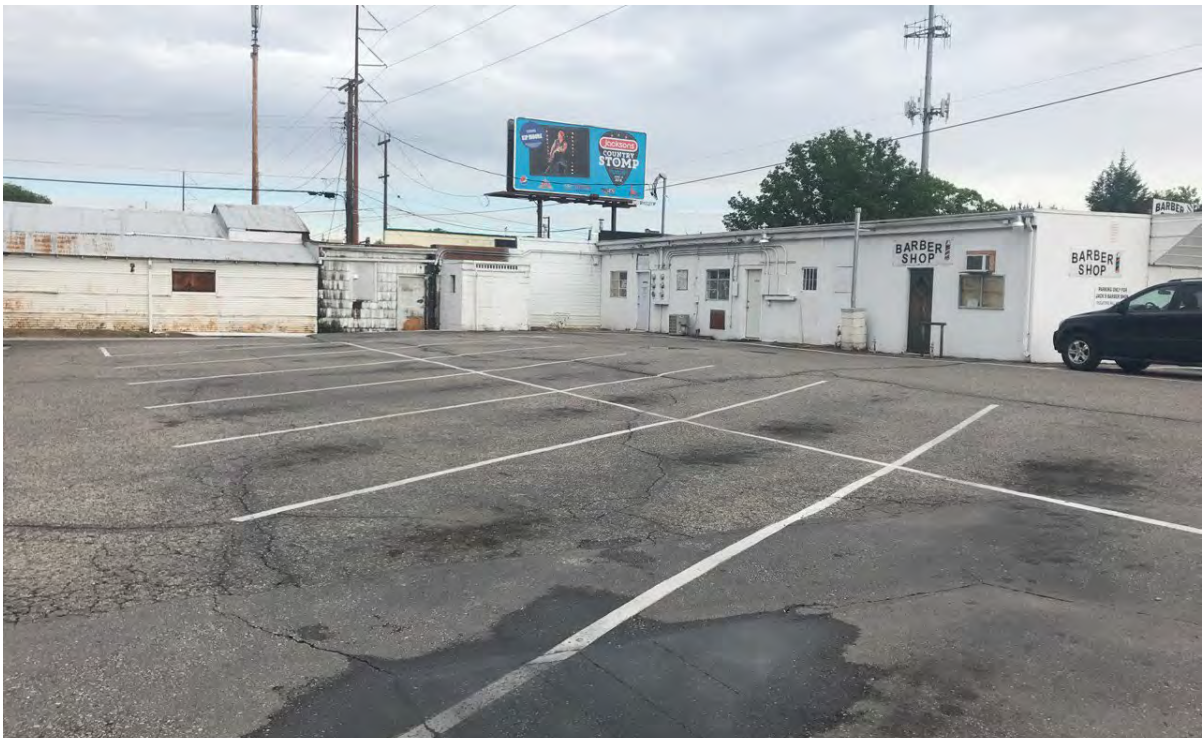
Deteriorated parking lot along West Overland Road

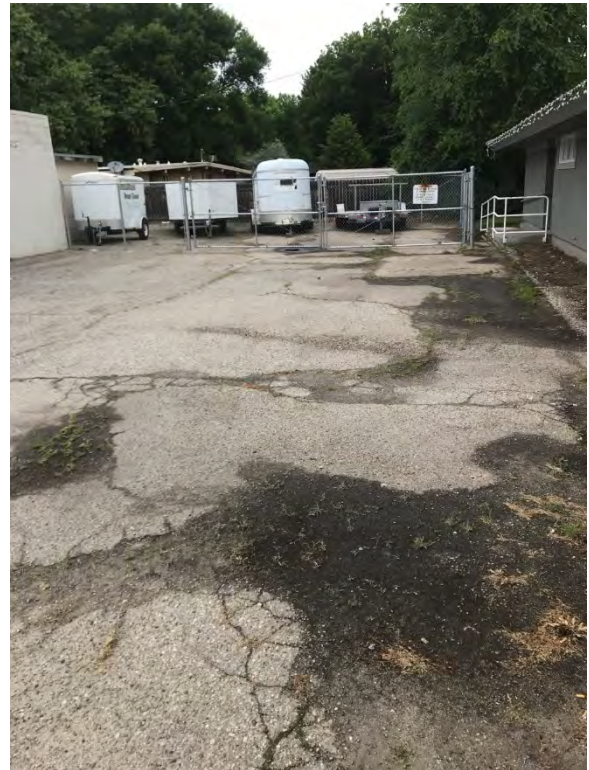
Deteriorated parking lot along West Overland Road

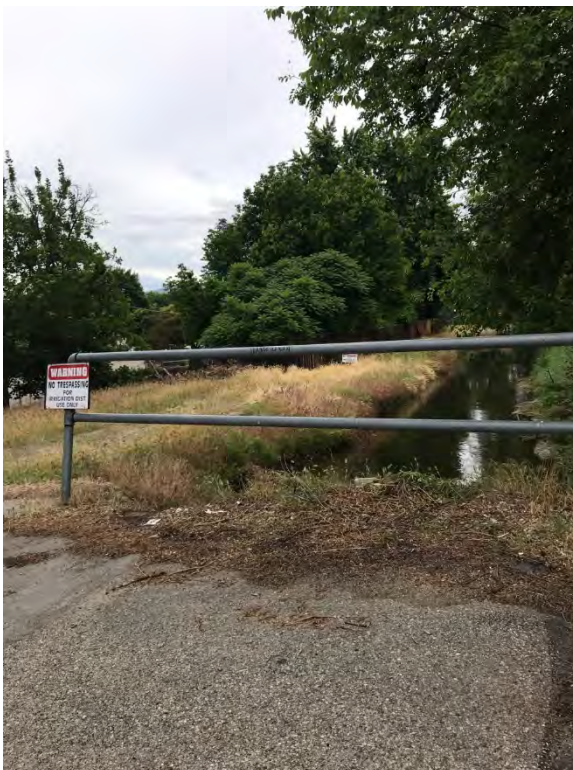
Unguarded or unscreened canals pose a hazard, especially for young children, along West Martin Street

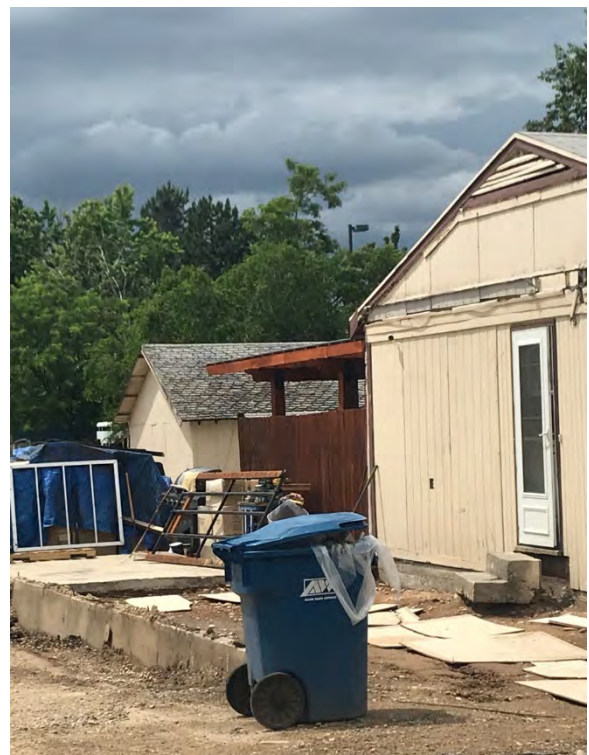
Debris and materials along South Orchard

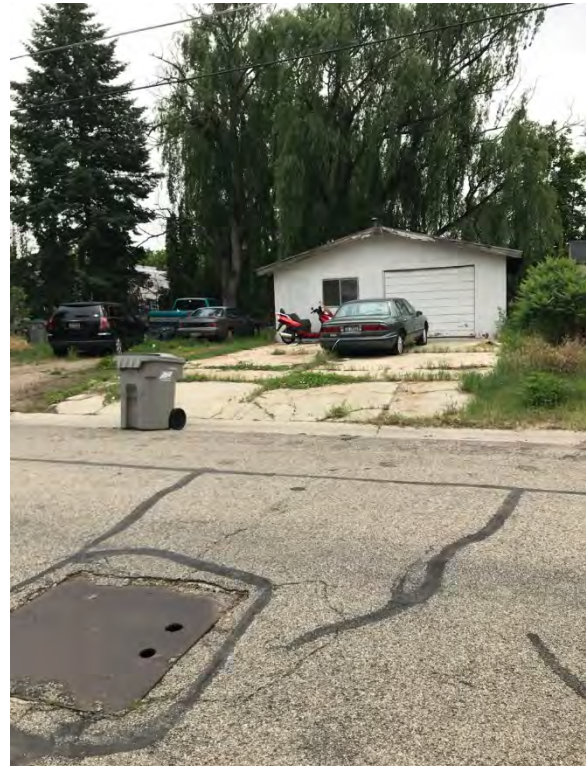
Deteriorated right-of-way and site on West Marvin Street

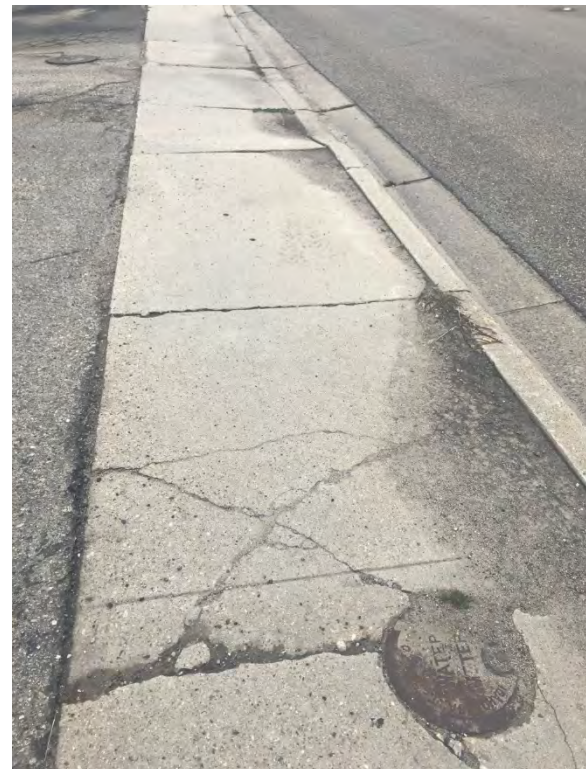
Deteriorated sidewalks along West Overland Street between South Cleveland Street and South Latah Street

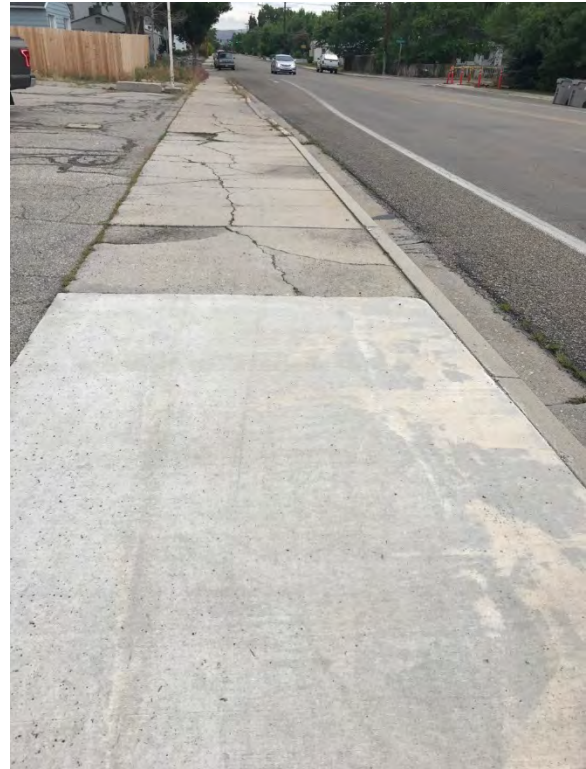
Deteriorated sidewalk and parking lot along South Latah Street

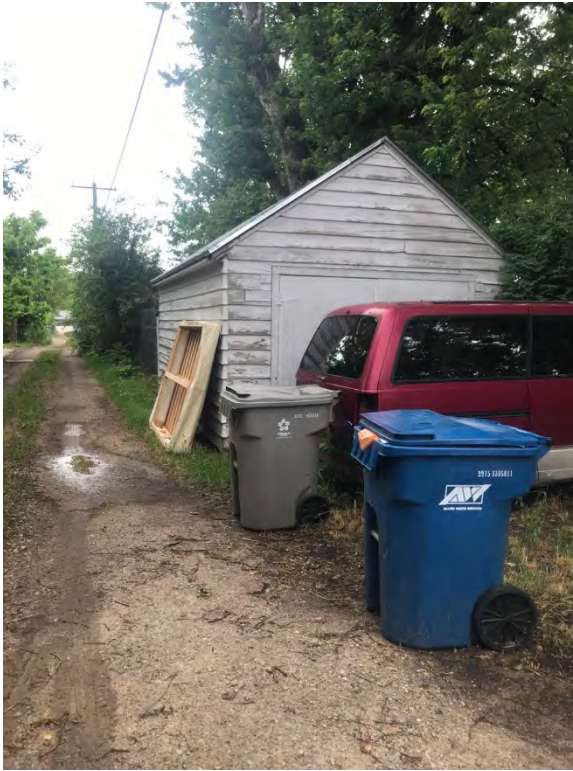
Deteriorated alley with debris near South Pacific Street

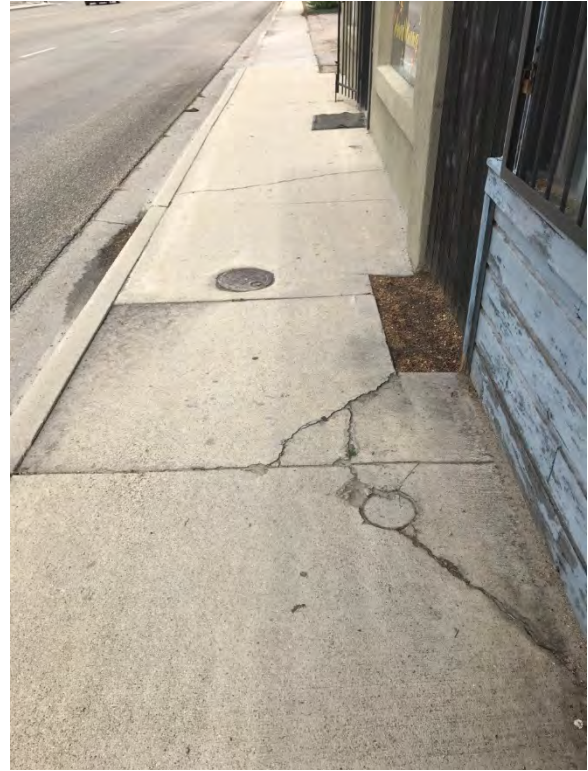
Narrow sidewalk directly adjacent to a travel lane on West Overland Street between South Gourley Street and South Hervey Street. Current pedestrian safety guidelines recommend a minimum five-foot buffer between traffic and pedestrians.

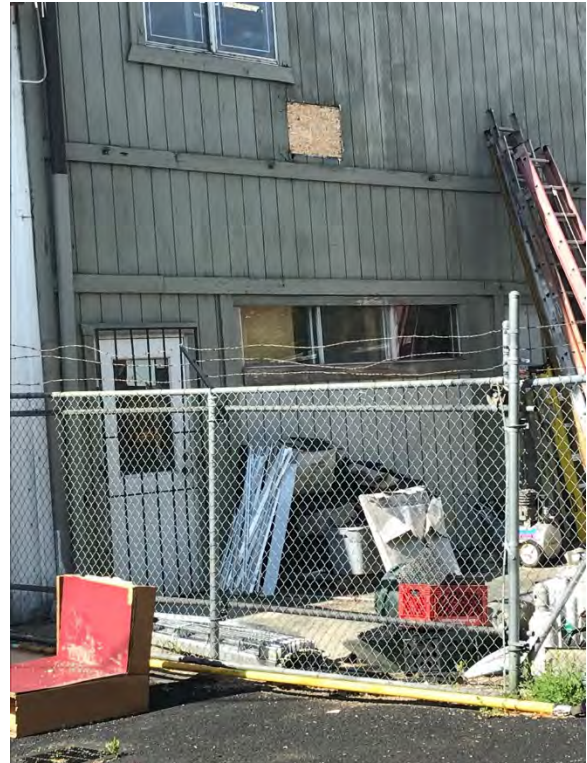
Deteriorated building conditions on West Grover Court

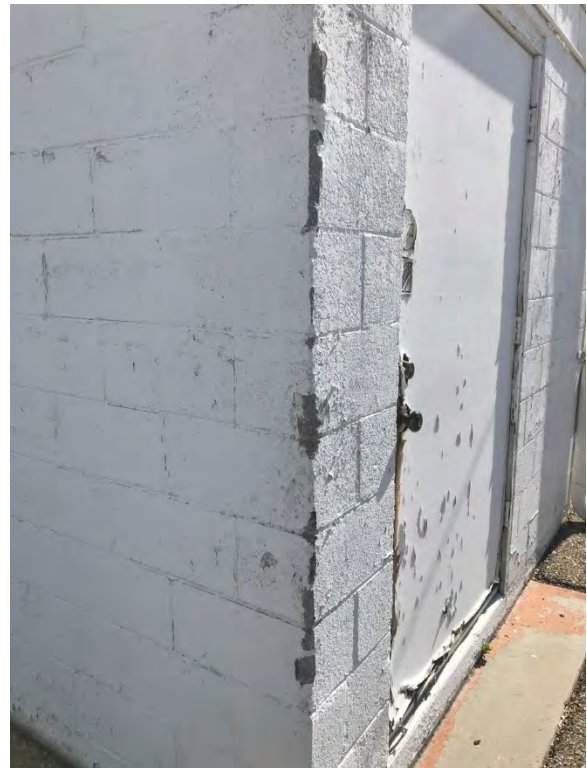
Peeling exterior paint and deteriorating entryway on South Vista Avenue

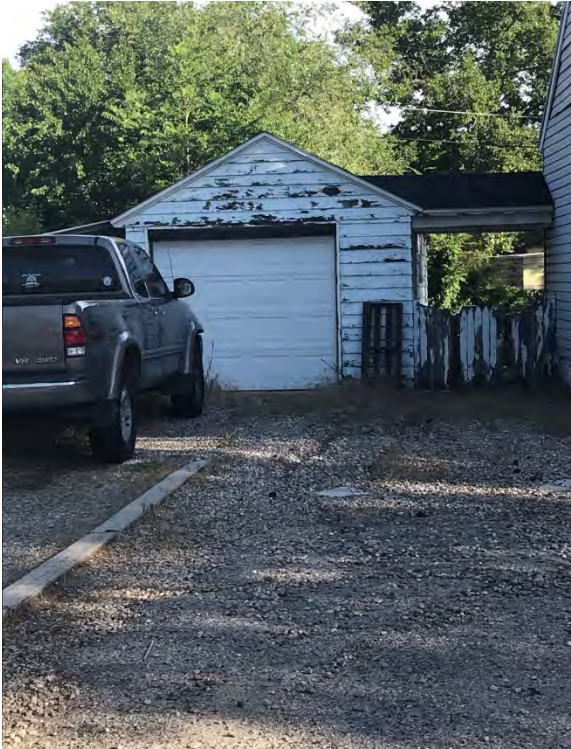
Peeling paint on garage along West Overland Road

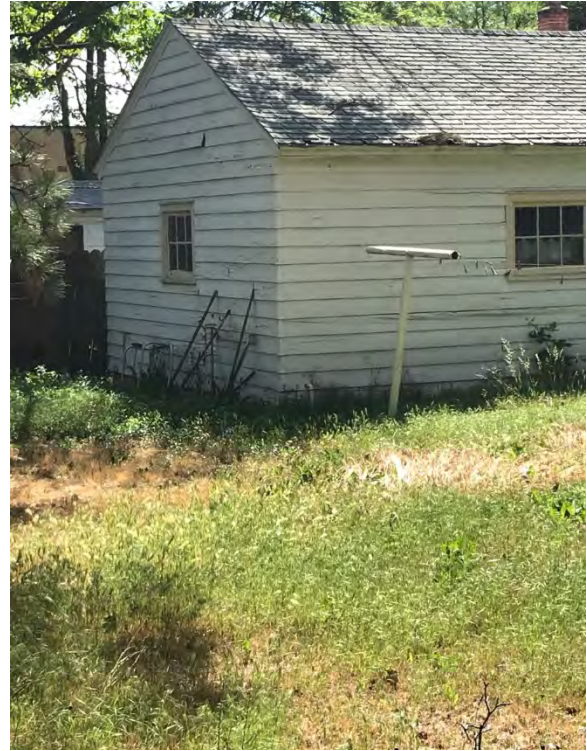
Exterior deterioration on West Edson Street

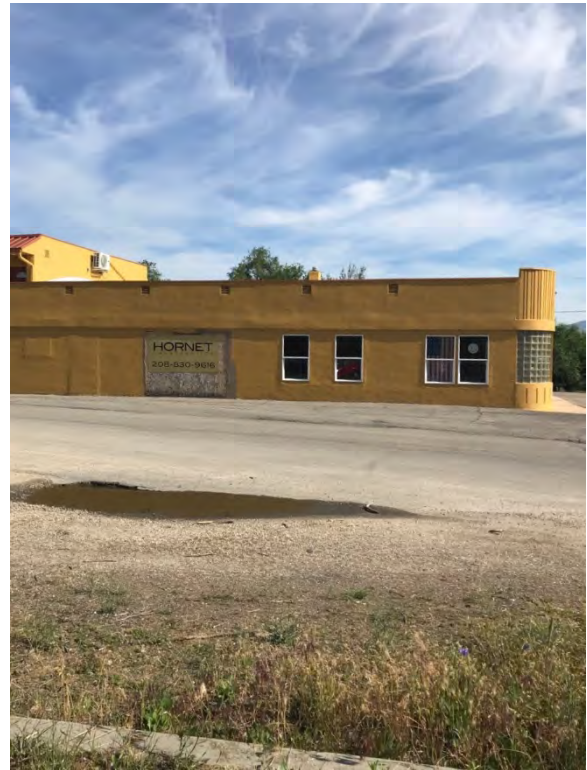
Vacant building on South Vista Avenue

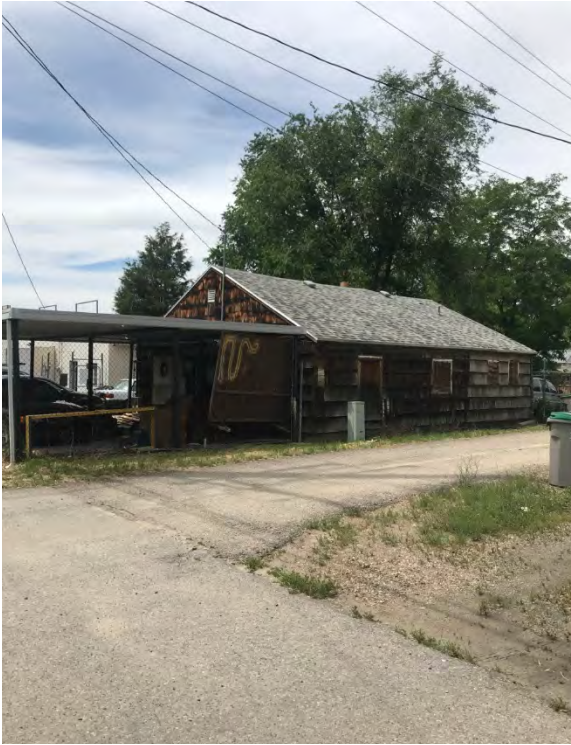
Deteriorated building on South Vista Avenue

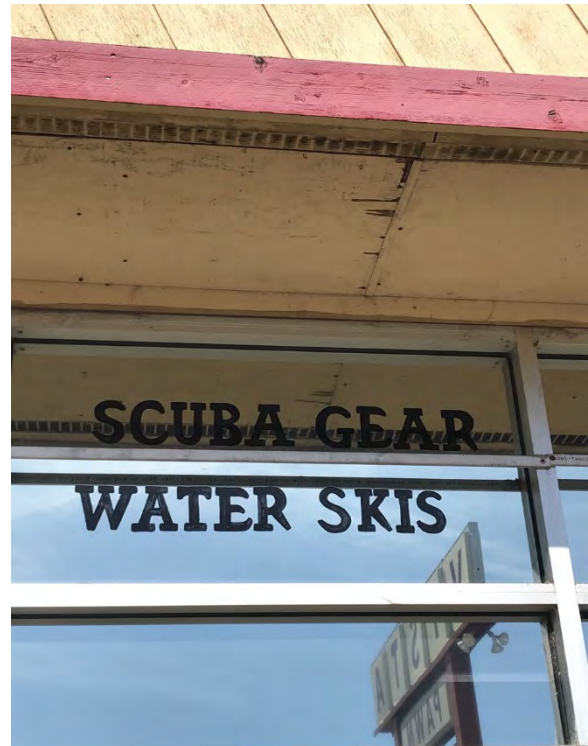
Deterioration to entrance along South Vista Avenue

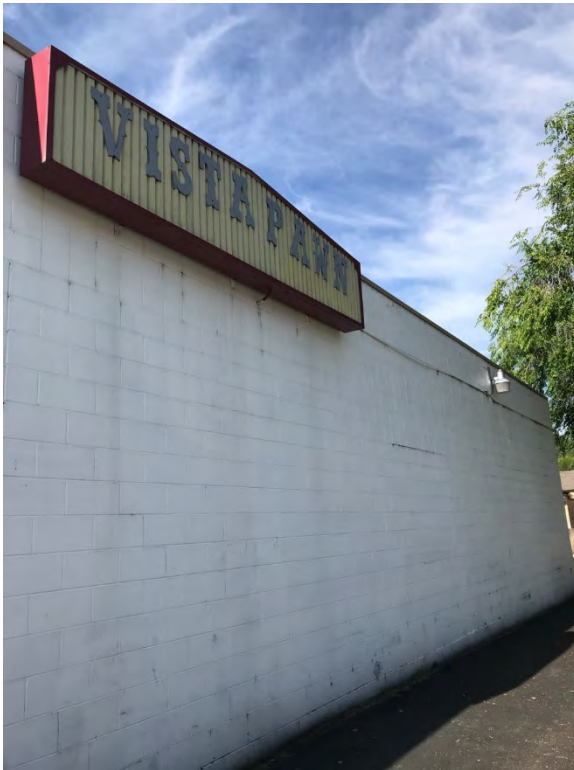
Pocked and deteriorating cement block wall with peeling paint on South Vista Avenue.

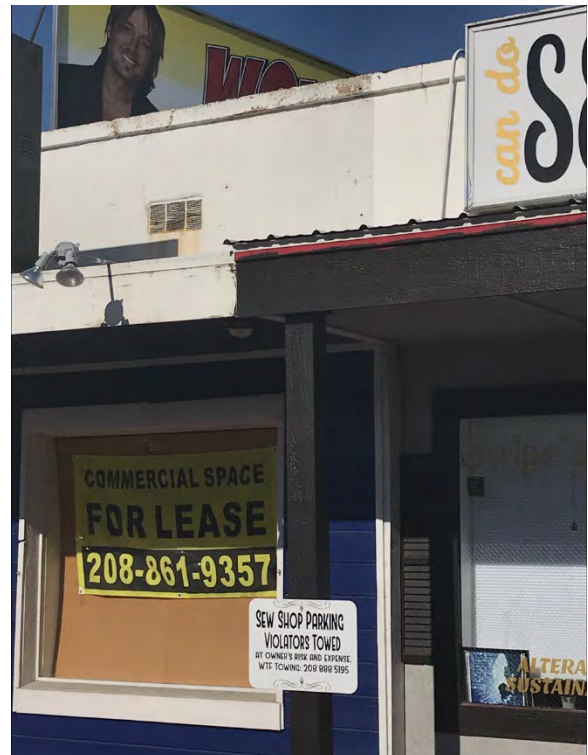
Rusting roof line above vacant commercial space on South Vista Avenue

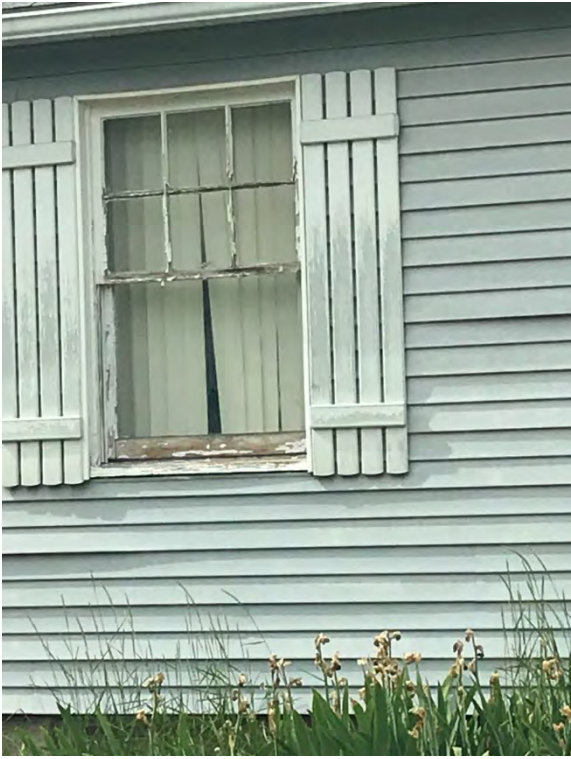
Deteriorated wooden window casing and siding on West Ponderosa Road

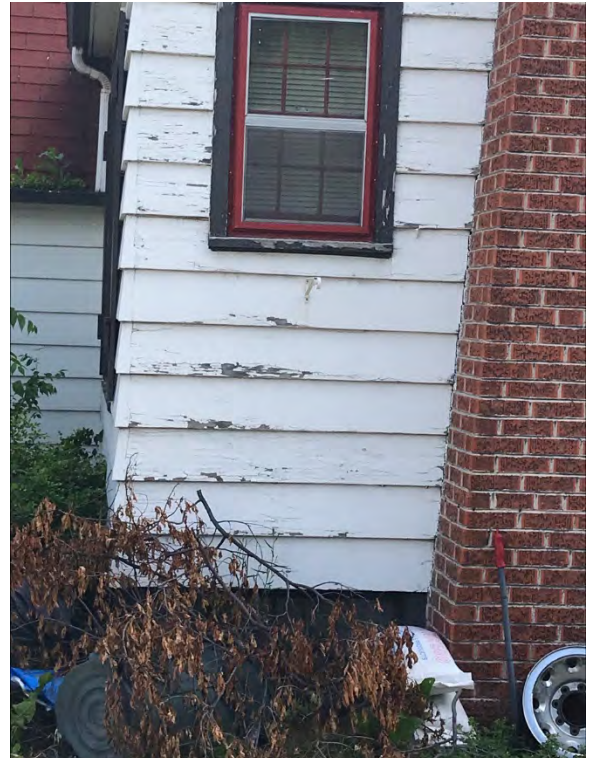
Peeling paint and deteriorating wooden window casing on West Kootenai Street

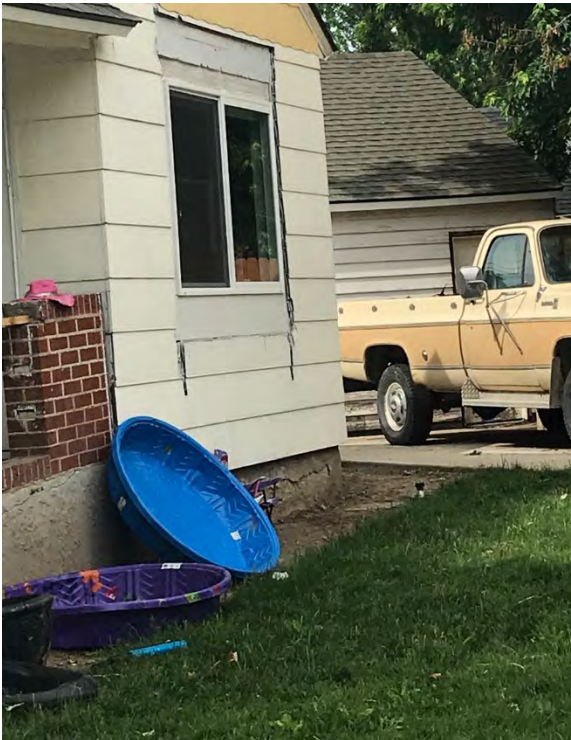
Deteriorated siding around window on West Juniper Street

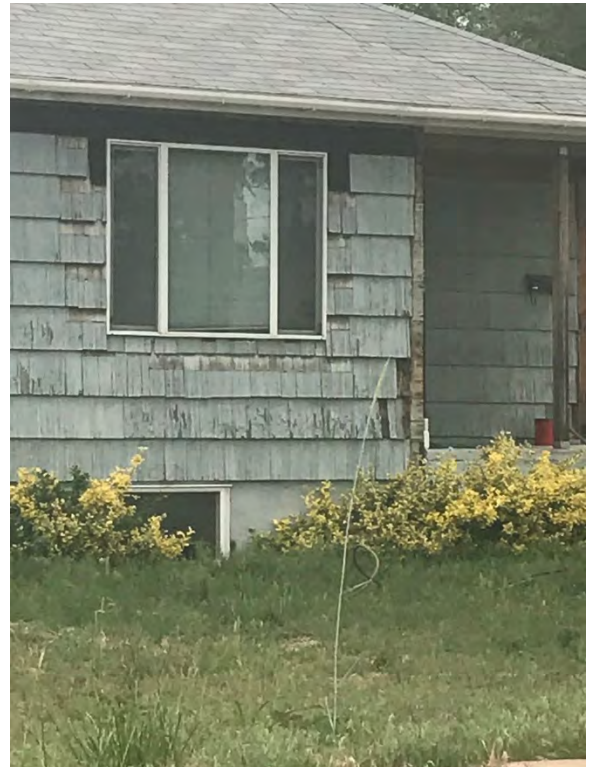
Deteriorated wooden siding on South Victoria Drive

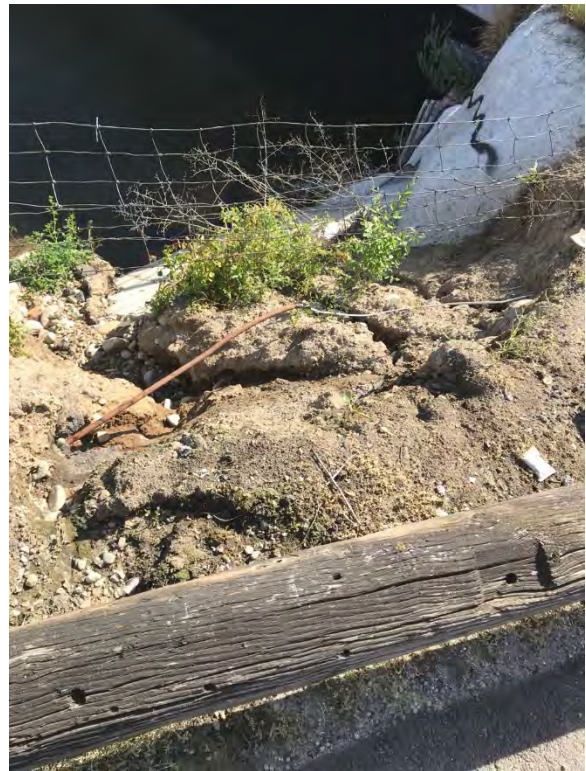
Canal opening along South Vista Avenue. Wire fence is an inadequate barrier to entry, creating an unsafe condition. The bottom picture shows a rusted protruding piece of rebar, which creates an injury risk.

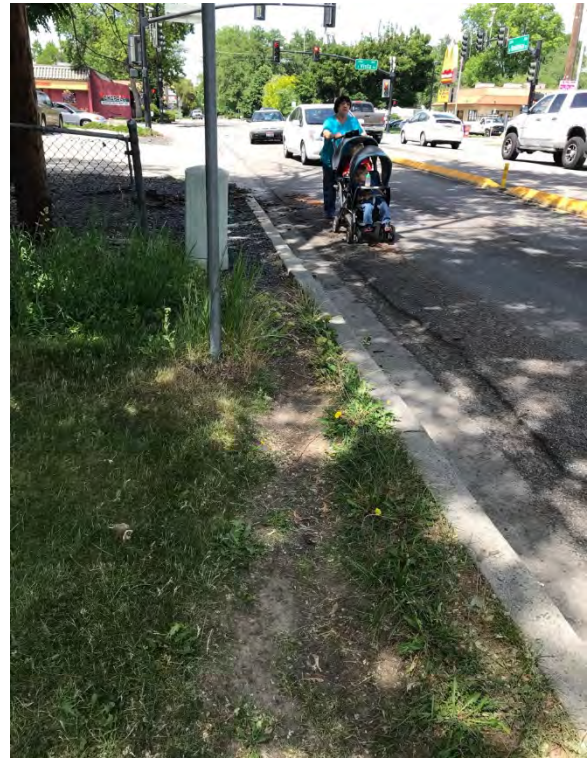
A pedestrian pushes a stroller in the street along South Vista Avenue due to the lack of pedestrian infrastructure while a car moves to pass on the left.

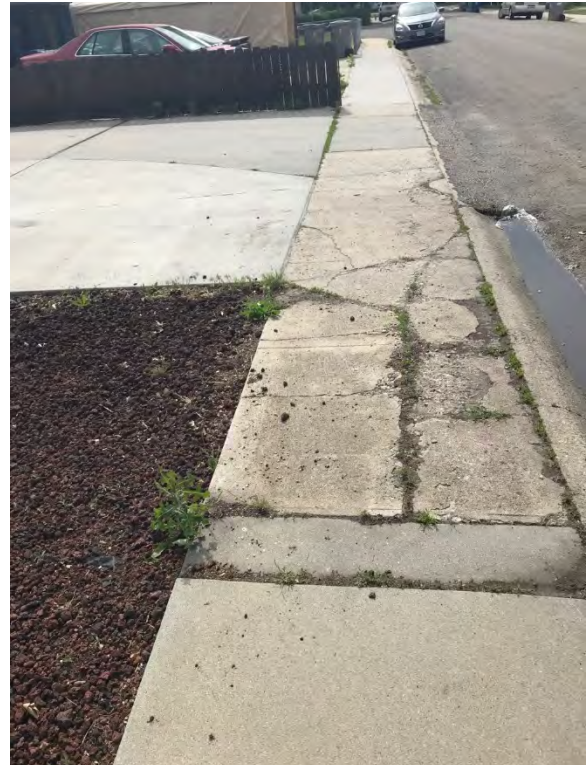
Cracked and uneven sidewalks along West Ponderosa Road

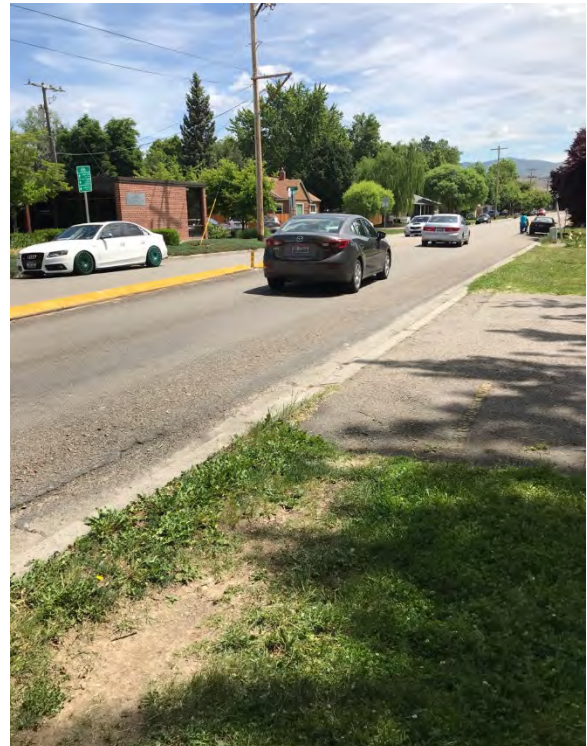
Lack of pedestrian infrastructure along both sides of West Kootenai Street, with evidence of pedestrian activity where the grass has been worn away.

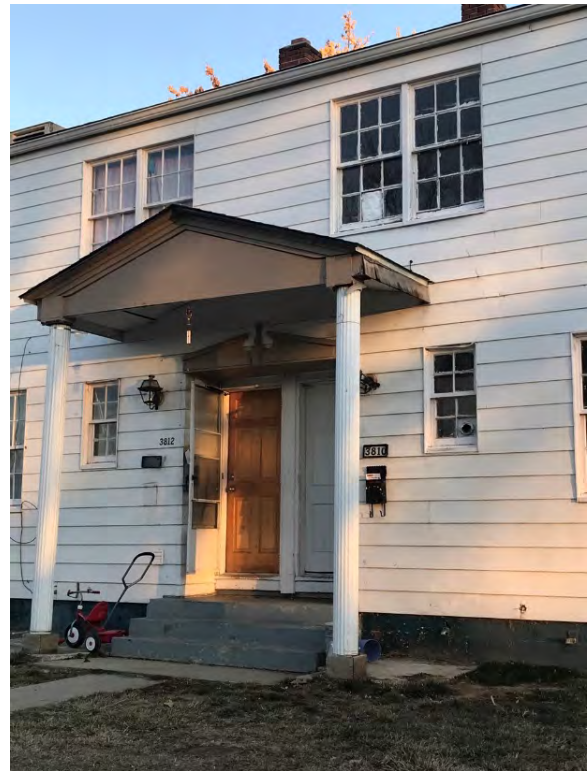
Frame multi-family building on West Pershing constructed in 1941 showing evidence of deterioration and not in conformance with current fire code, posing a safety risk to residents.

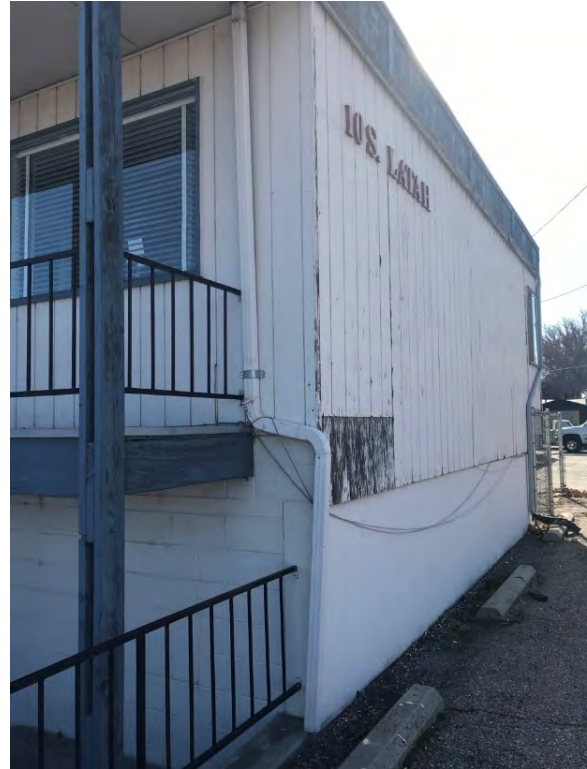
Commercial building on South Latah Street dating from 1967 that shows signs of deterioration, obsolescence, and lack of economic productivity due to high vacancy and inefficient use of the site.
