Capital City Development Corporation

Central Bench Study Area

Urban Renewal Area Eligibility Report

April 8, 2019

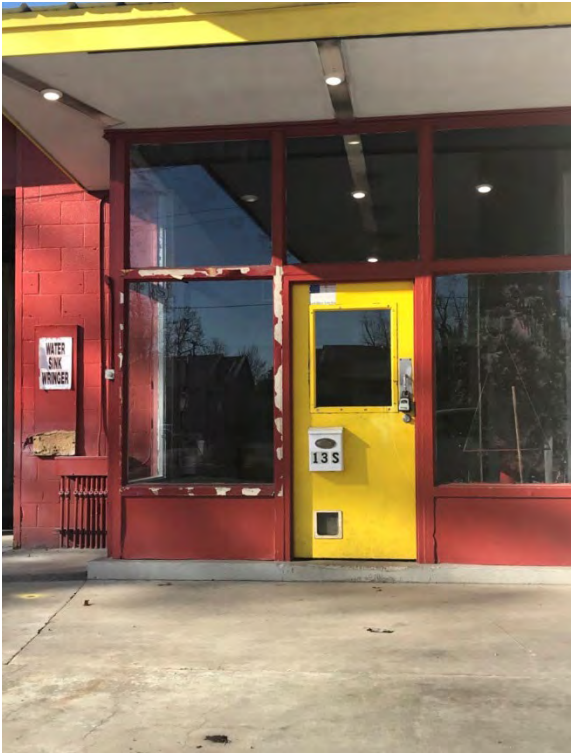
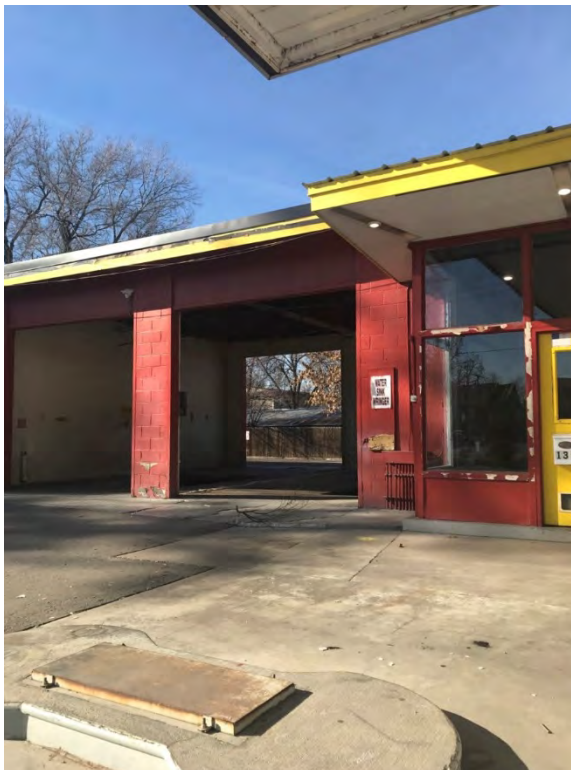
Vacant car wash on South Latah Street shows signs of deterioration and weathering.

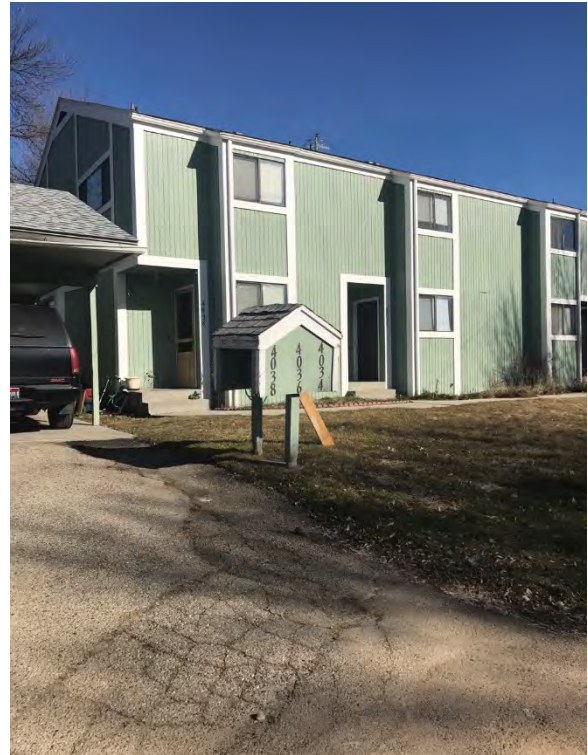
Apartments on West Glenn Street are located at the end of a dead-end street that is inadequate for emergency vehicle access

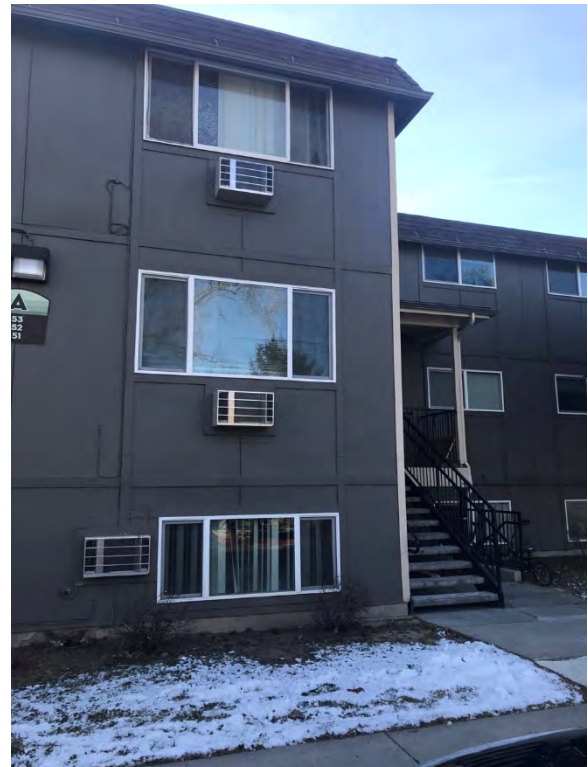
Apartments on West Alpine Street have several obsolete building features including through-wall air conditioning units and a lack of sprinklers

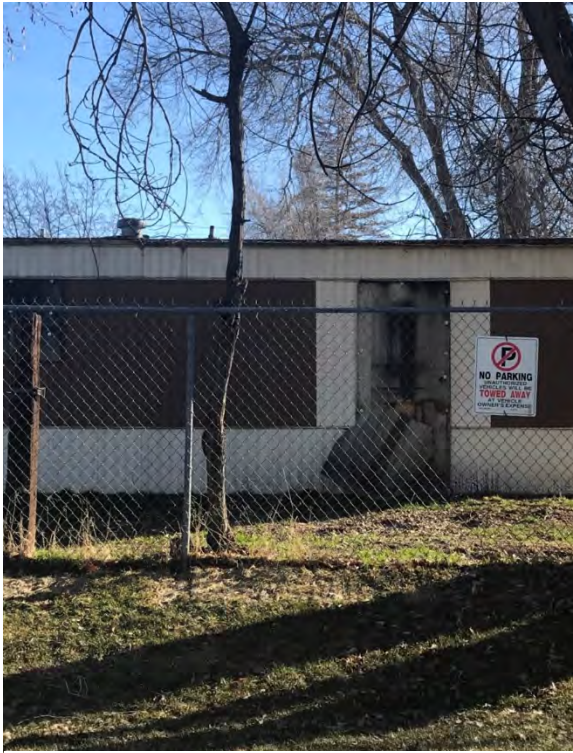
Deteriorated trailer building behind West Alpine Street

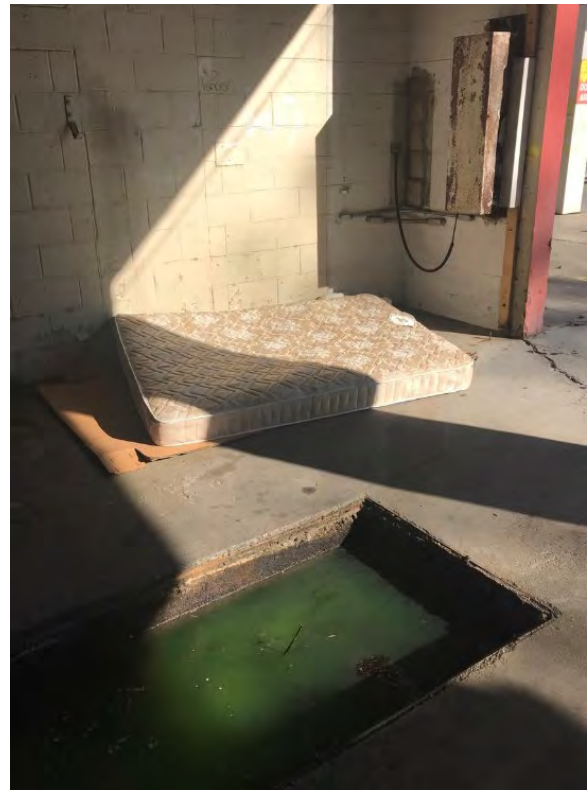
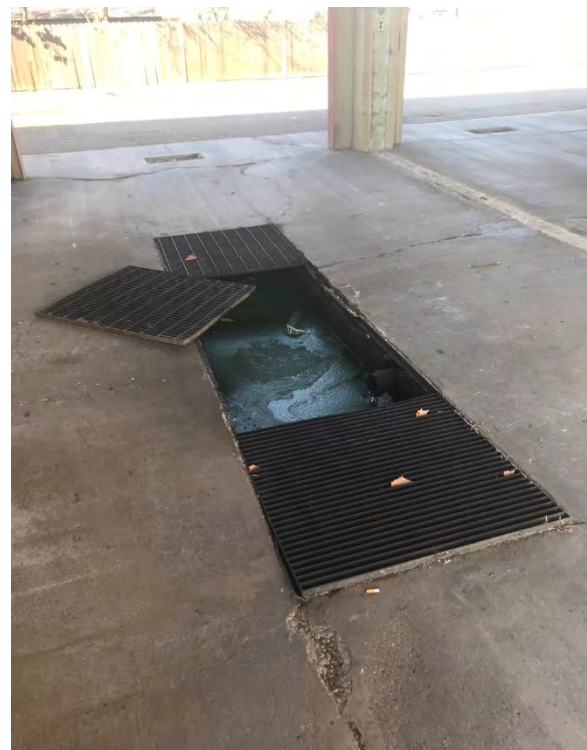
Vacant car wash building on South Latah Street shows evidence of illegal dumping and uncovered and unsafe drainage troughs filled with green and oily liquid.

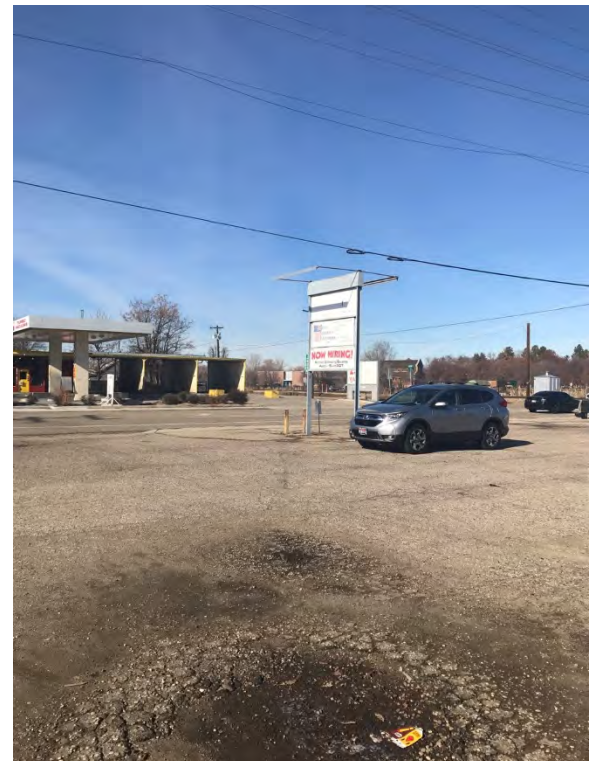
Deteriorated parking lot of mostly-vacant commercial building on South Latah

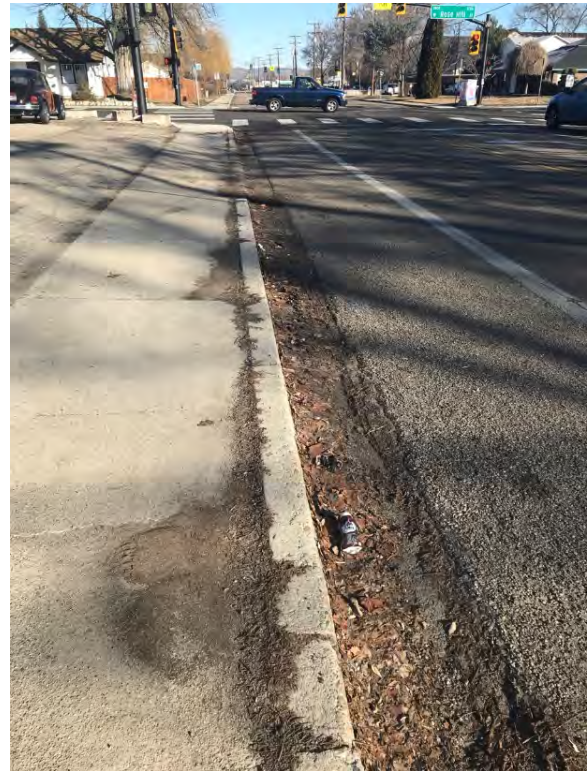
Deteriorated sidewalk, curb, and right-of-way along West Rose Hill street looking north.

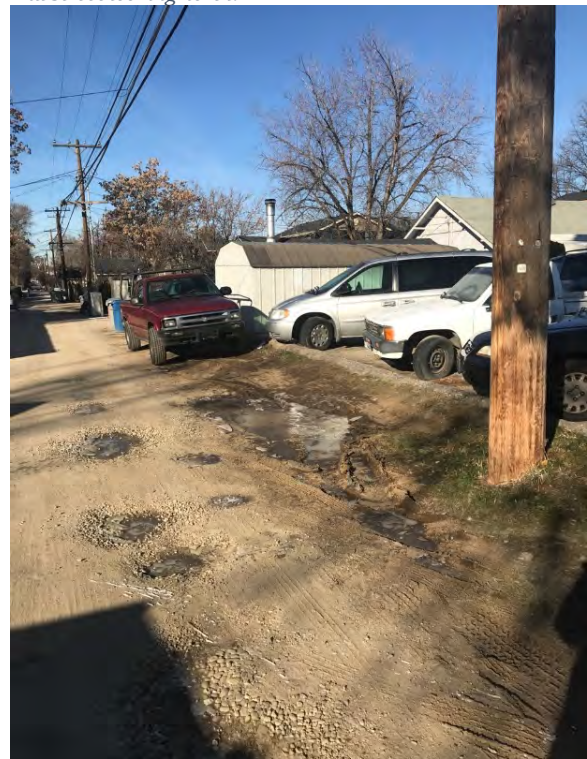
Unpaved dirt alley between Rose Hill Street and West Grover Street west of South Latah Street showing deterioration from wet and icy weather.

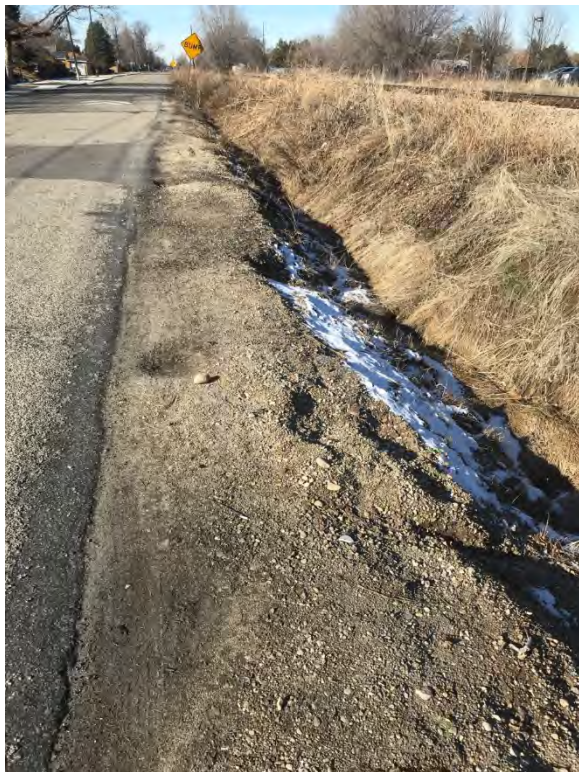
Deterioration of right-of-way on West Alpine Street west of Latah Street
