Capital City Development Corporation

Central Bench Study Area

Urban Renewal Area Eligibility Report

April 8, 2019

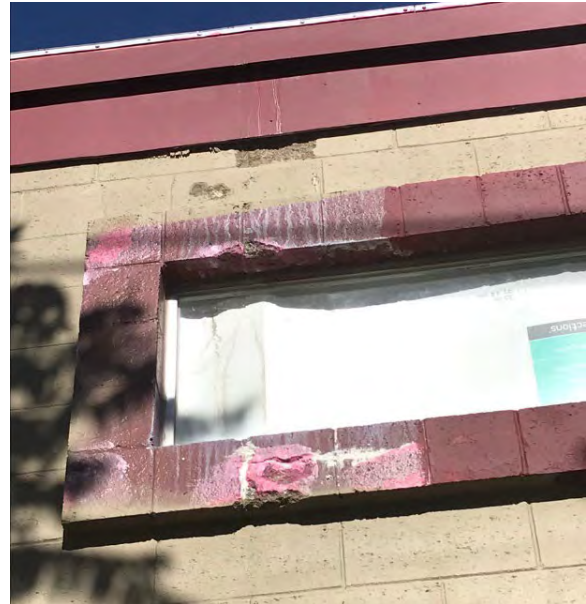
Deterioration and leaching of concrete on West Franklin building due to water.

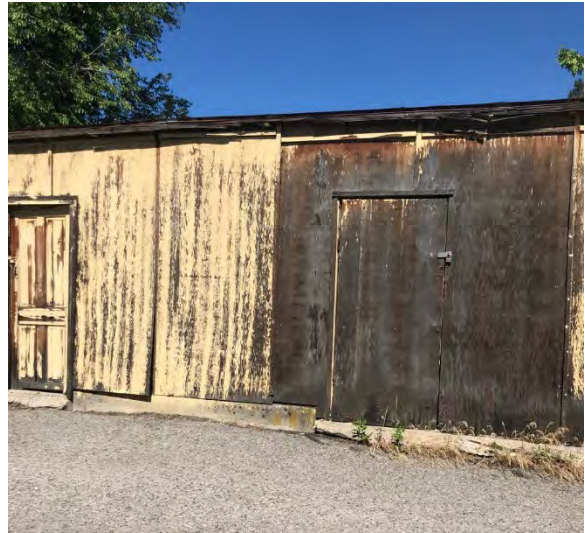
Rusting metal exterior on North Stanley Street

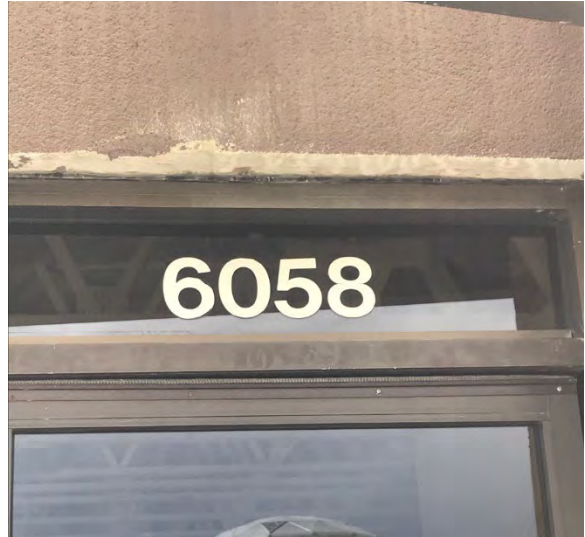
Structural deterioration at any entryway on West Corporal Lane

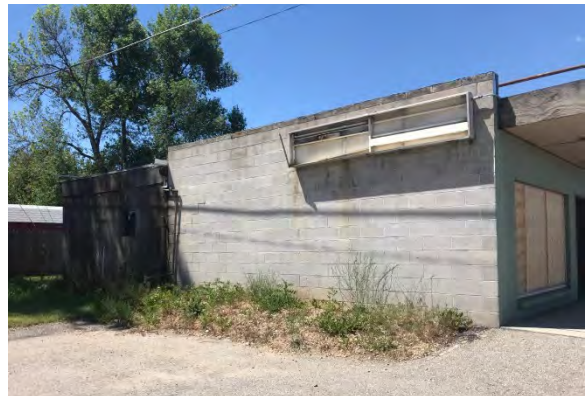
Deteriorated building exterior on Stanley Street

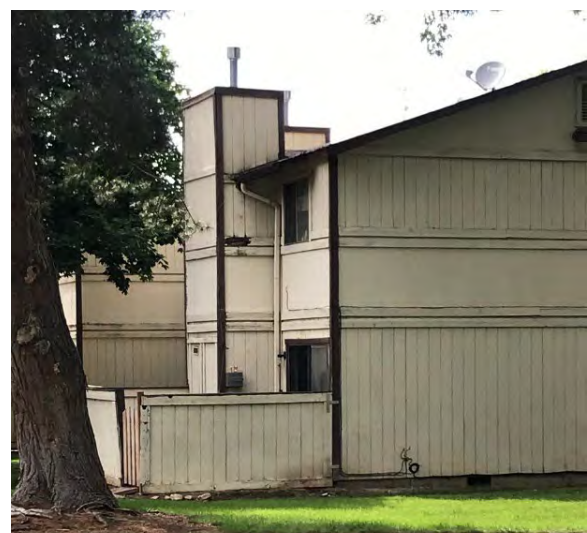
Deteriorating building exterior on West Morris Hill

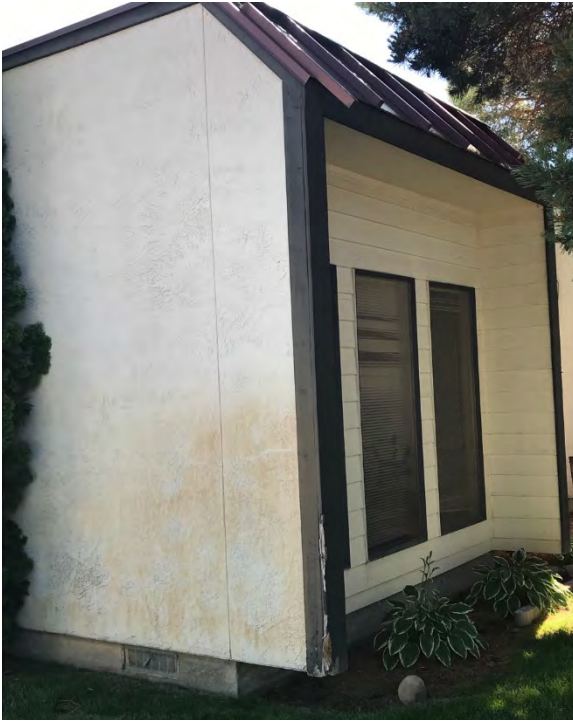
Damage to wall on West Franklin Road

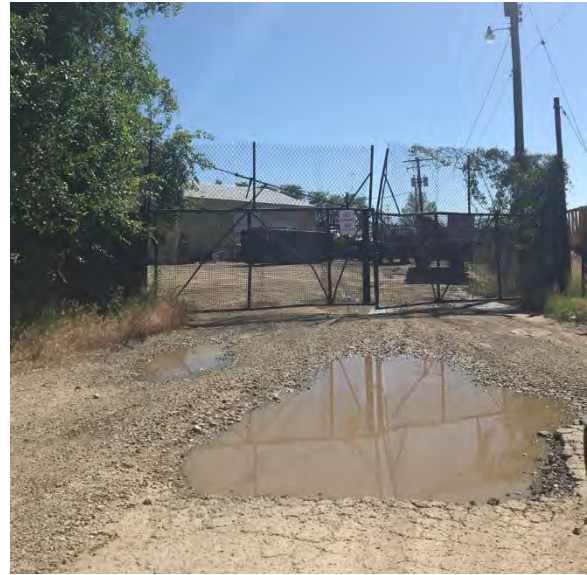
Entrance along West Gage Street showing inadequate drainage, cracked and deteriorated pavement, overgrowth of vegetation, and fence in disrepair.

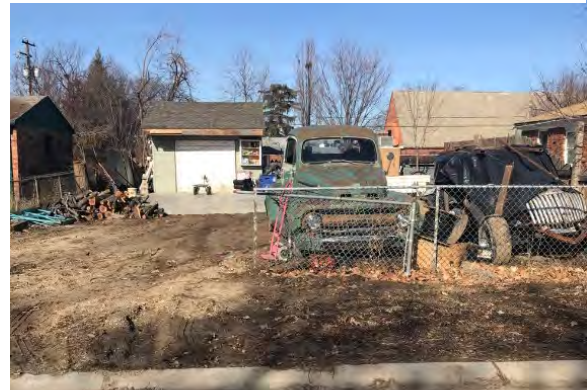
Site deterioration and insanitary conditions, with a deteriorating truck creating potential ground contamination on West Clinton Street

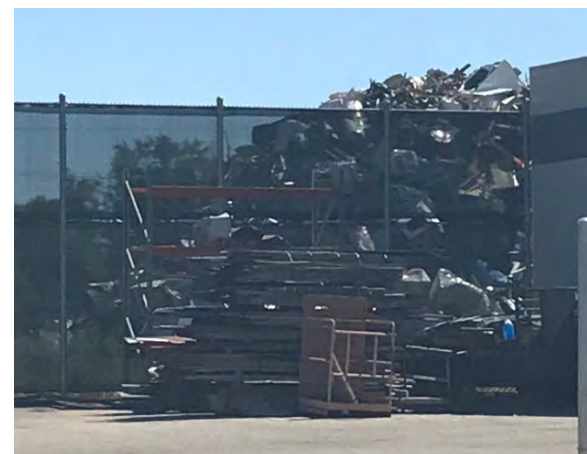
Heaped scrap metal and industrial materials on West Gage Street

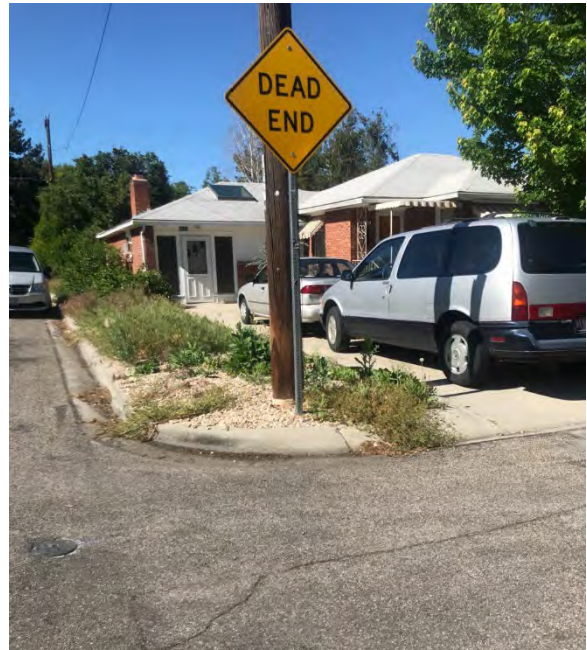
Dead end sign on Corporal Street, at the intersection of Corporal Street and North Stanley Street, facing north. Lack of street connectivity leads to inadequacies in the transportation network. Also visible in the photo is a lack of sidewalks on both streets, forcing pedestrians to walk in the street.

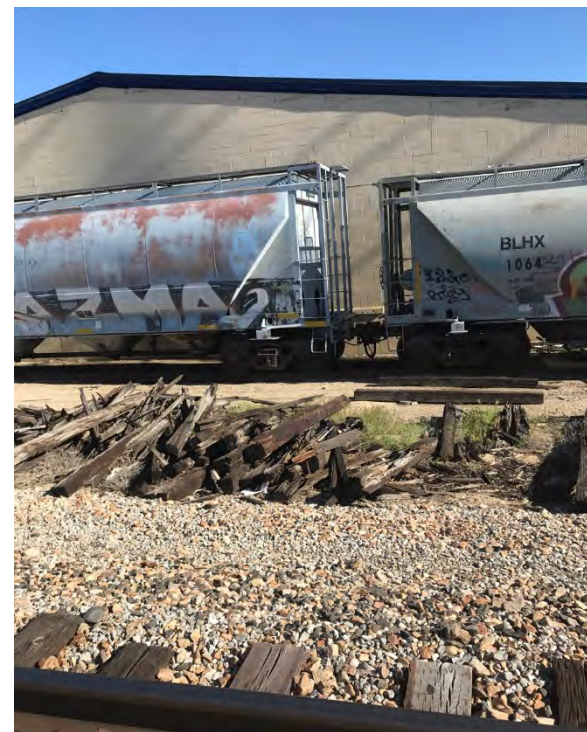
Rail cars along West Franklin. The Union Pacific rail lines interrupt the street network throughout the subarea and impede through traffic.

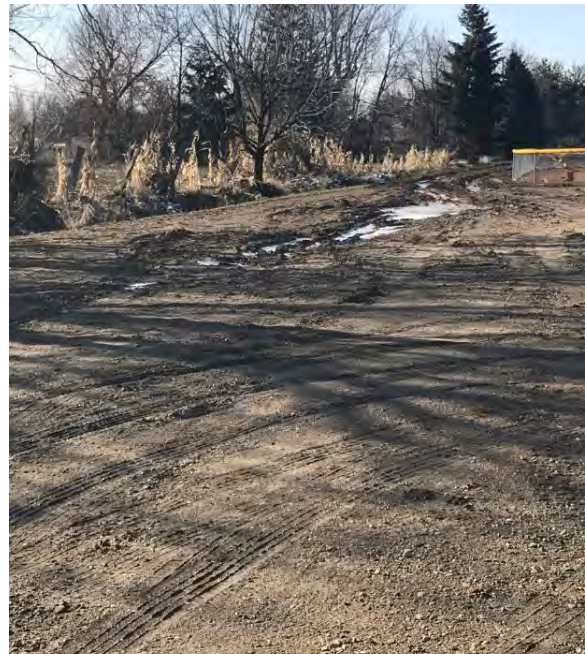
Dirt roads on the periphery of Liberty Park that deteriorate when it rains.

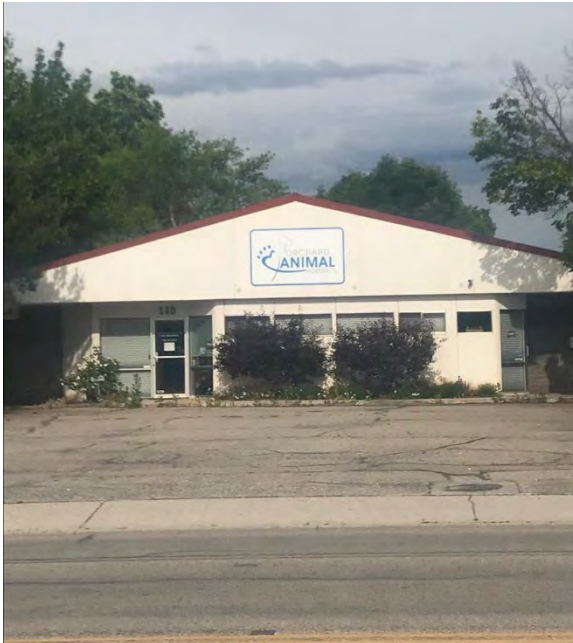
Lack of access management on North Orchard Street. Managed access points, such as right-turn driveways, encourages drivers to slow down to enter the parking lot, and makes the road safer and more comfortable for pedestrians.

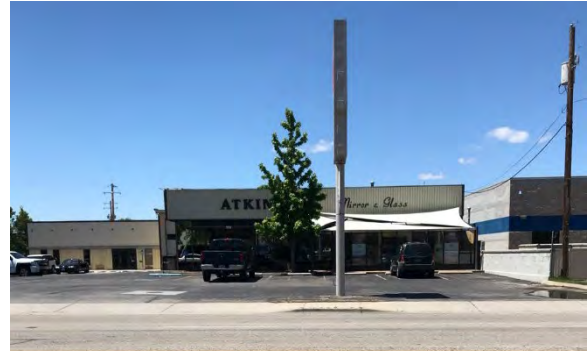
Parking lot entrances along North Orchard Street are overly wide, which can endanger pedestrians

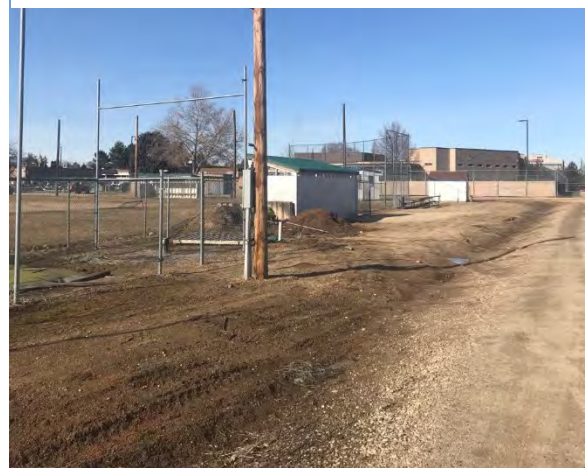
Site deterioration on West Denton Street on the northern edge of Liberty Park.

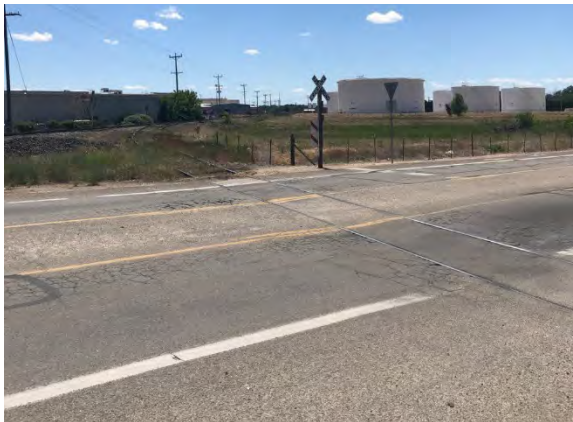
Deterioration of right-of-way at railroad tracks along West Emerald Street

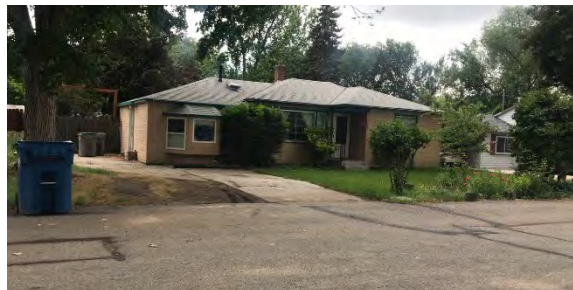
Deterioration of roadway on West Albion Street, with deteriorated asphalt and lack of drainage system. The lack of sidewalks also creates unsafe conditions for pedestrians.

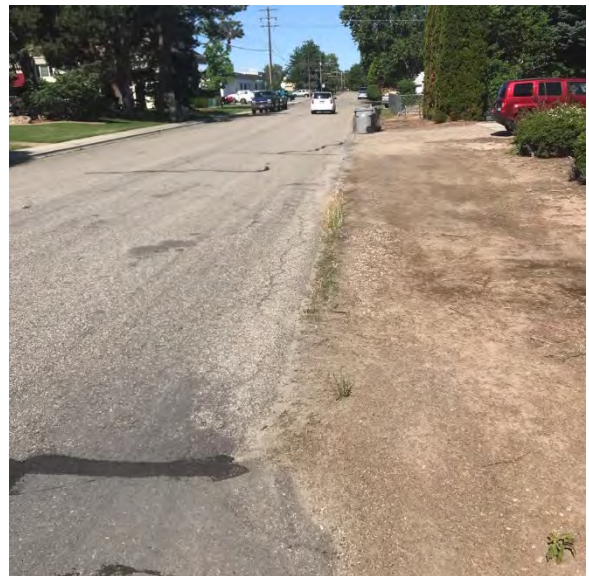
Deteriorated right-of-way and lack of sidewalks on West Bond Street between North Phillippi Street and North Laurel Street

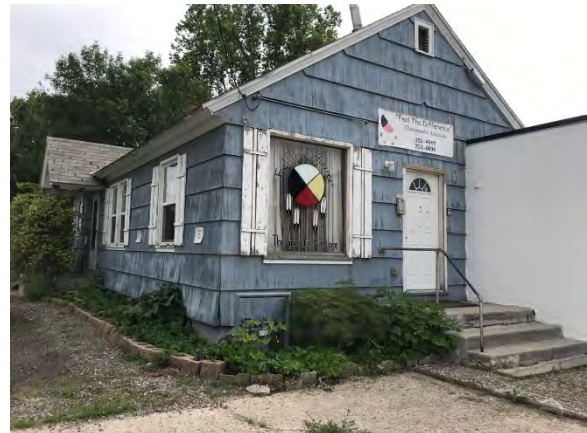
Dilapidated exterior building condition and evidence of obsolescence (residential building used as business) on West Overland Road

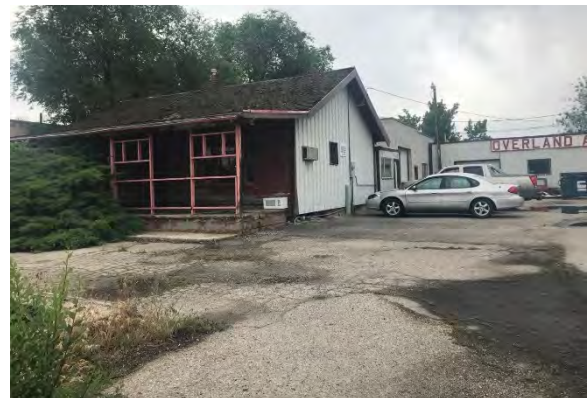
Deteriorated building and site on West Overland Road

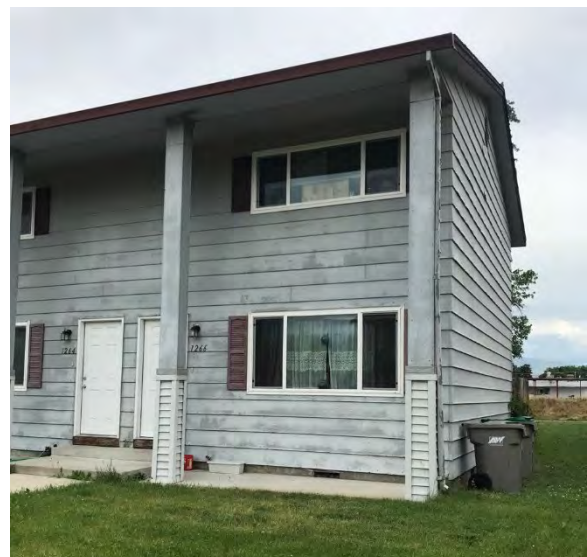
Wood frame deteriorated apartment building on South Security Lane.

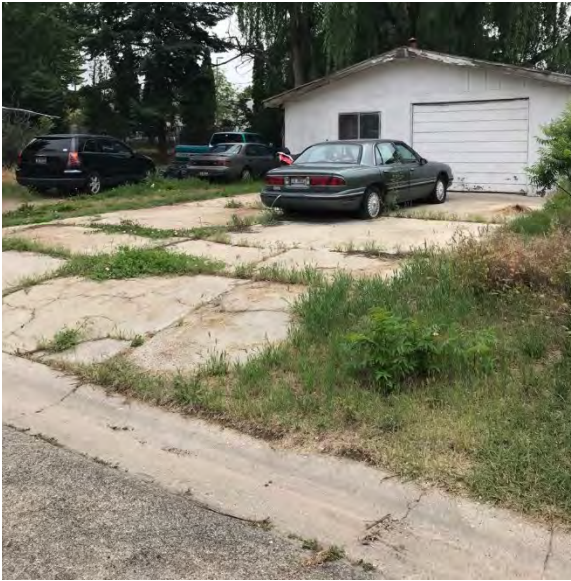
Structural and site deterioration, and overgrown vegetation on West Marvin Street

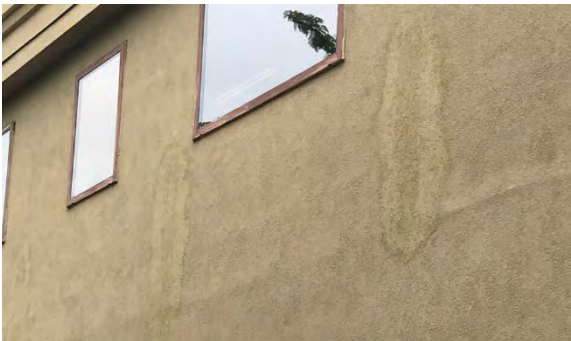
Moisture damage to a building exterior on West Overland Road

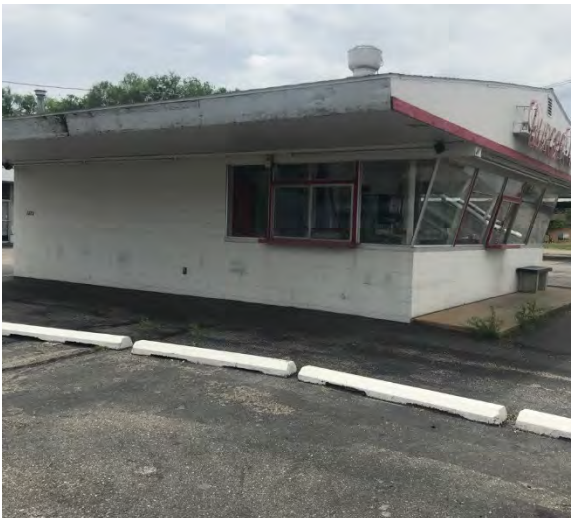
Vacant and obsolete cement block commercial building on South Orchard Street

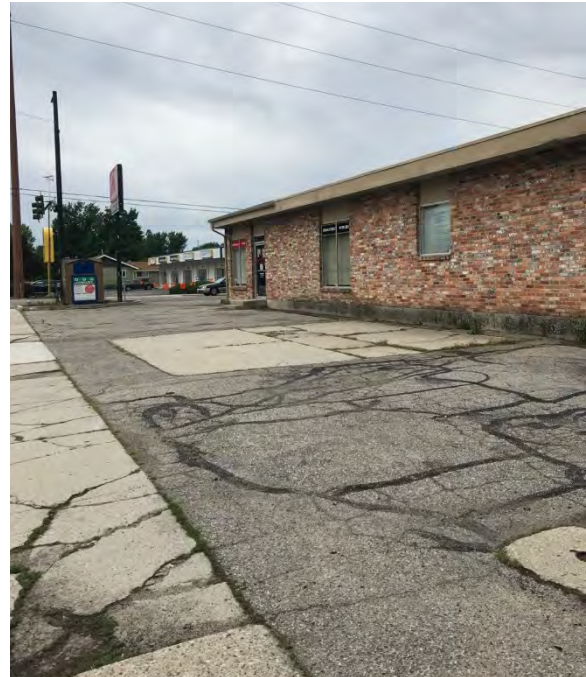
Cracked and patched parking lot on West Overland Road

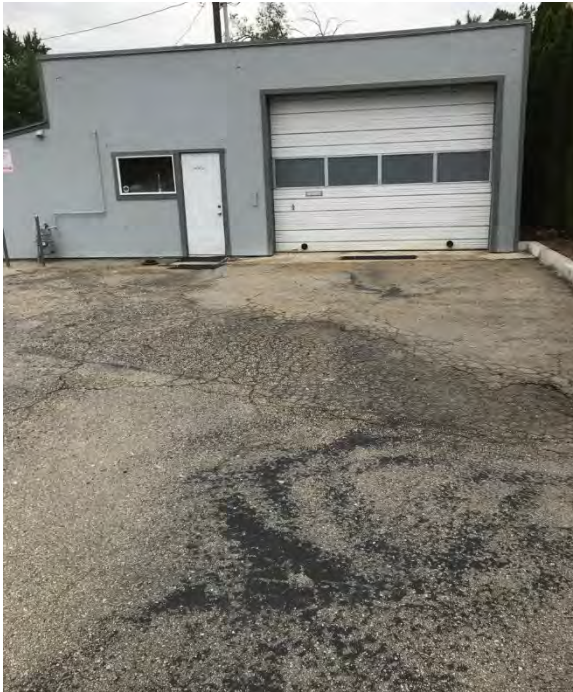
Deterioration of parking lot on West Overland Road

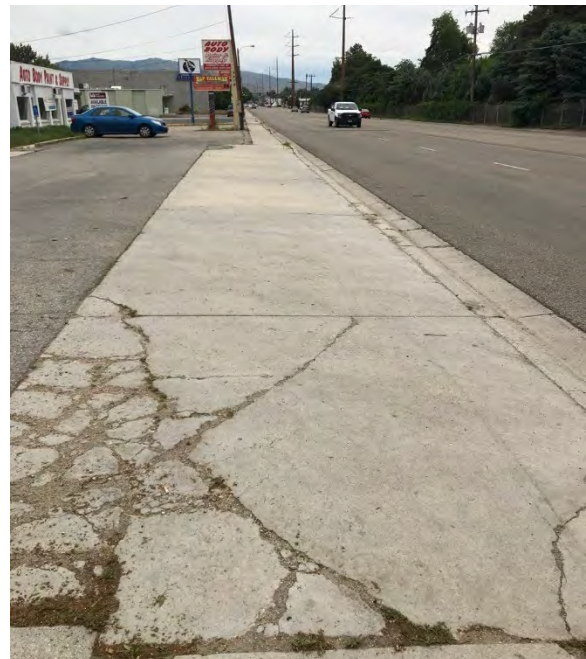
Deteriorated sidewalk on West Overland Road between South Wilson Street and South Orchard Street. At right, the sidewalk slopes to the gutter, providing a long and continuous driveway to the site at left, which is unsafe for pedestrians.

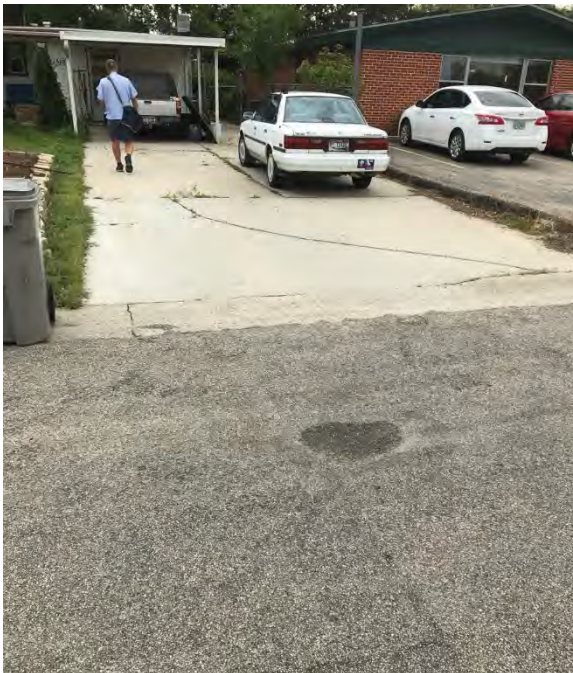
Lack of sidewalks on South Gourley Street

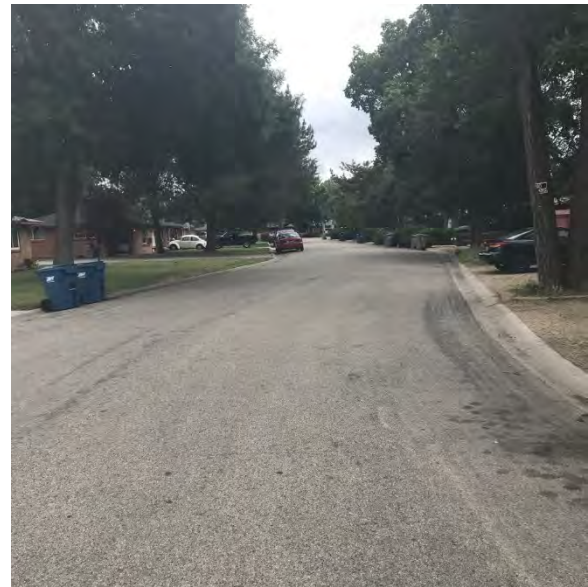
Inadequate provision of pedestrian infrastructure along West Blaser Circle.

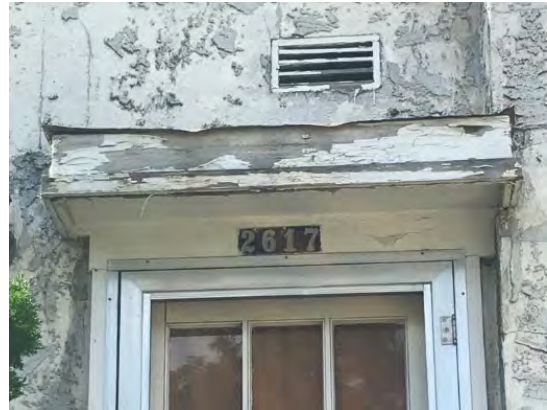
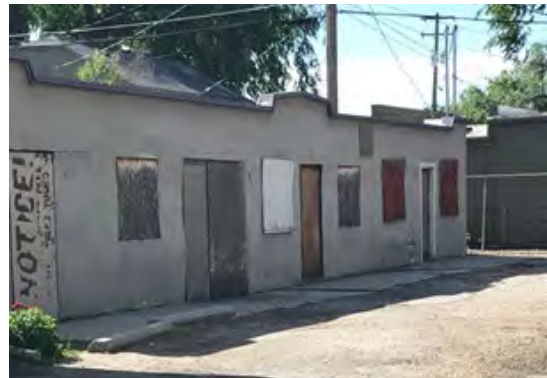
Structural deterioration on Rose Hill Street

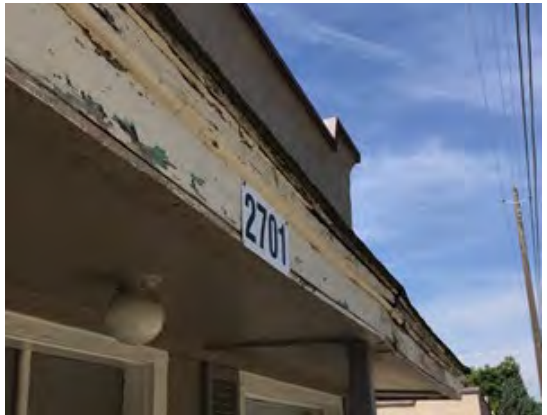
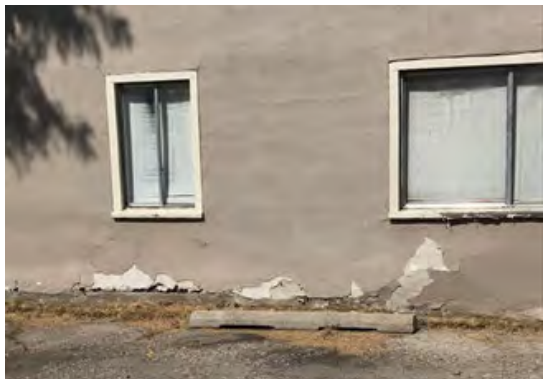
Structural deterioration on Rose Hill Street

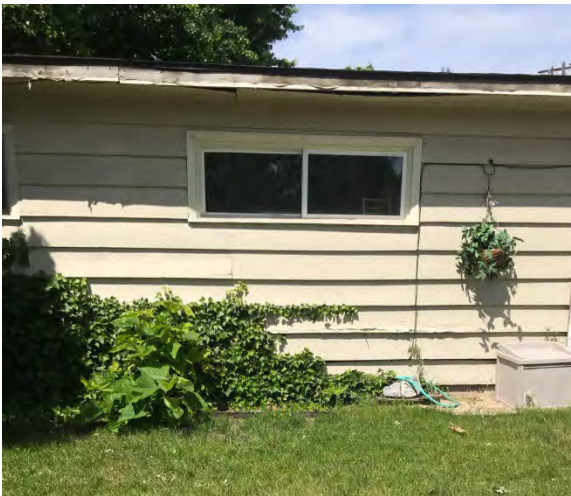
Deteriorating siding and roof on South Vista Avenue

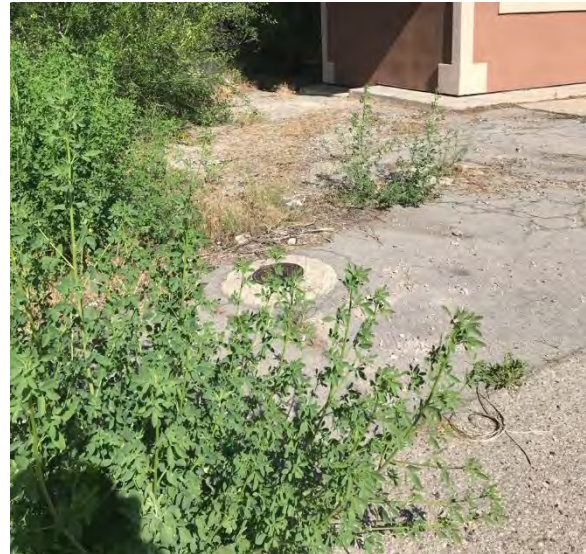
Overgrown vegetation and deteriorated asphalt on South Vista Avenue

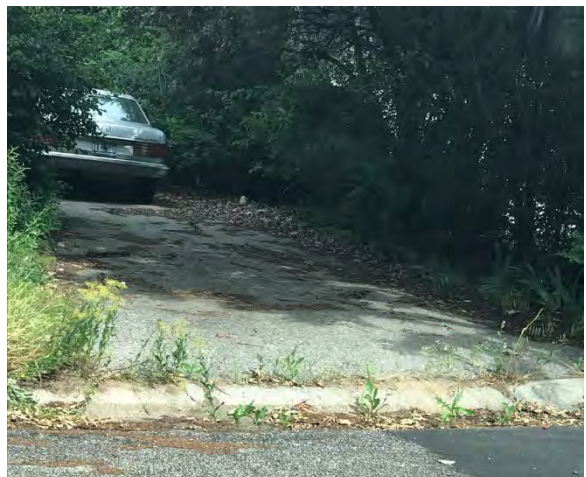
Deterioration of driveway and overgrowth of vegetation on South Broxon Street

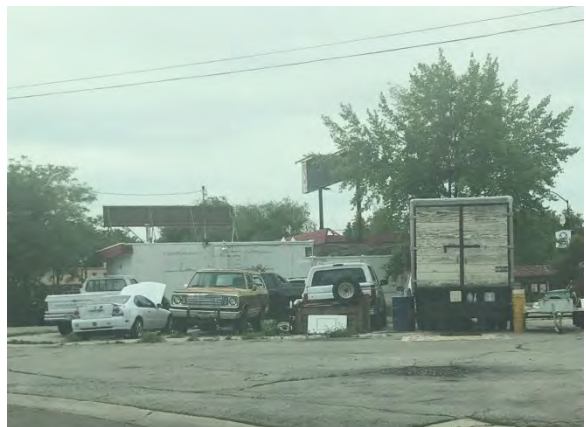
Irregularly parked cars on South Vista Avenue

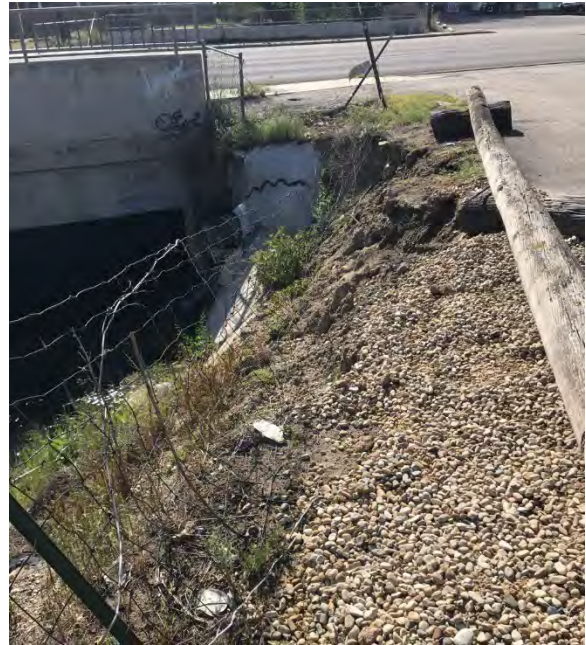
Canal opening along South Vista Avenue. Wire fence is an inadequate barrier to entry, creating an unsafe condition. The bottom picture shows a rusted protruding piece of rebar, which creates an injury risk.

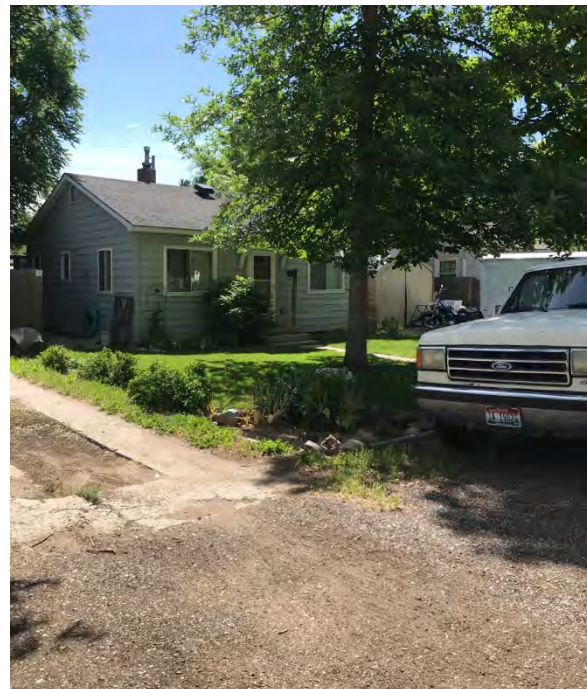
Lack of drainage infrastructure along South Broxon Street

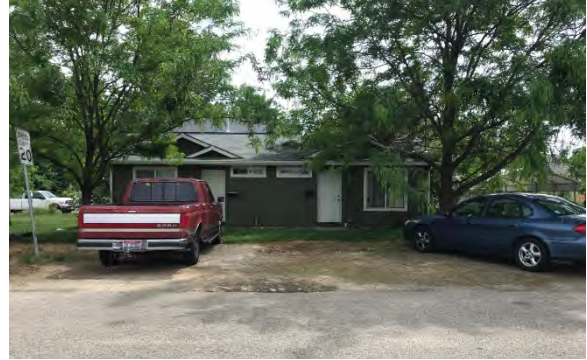
A lack of pedestrian infrastructure and unpaved driveway along West Nez Perce Street

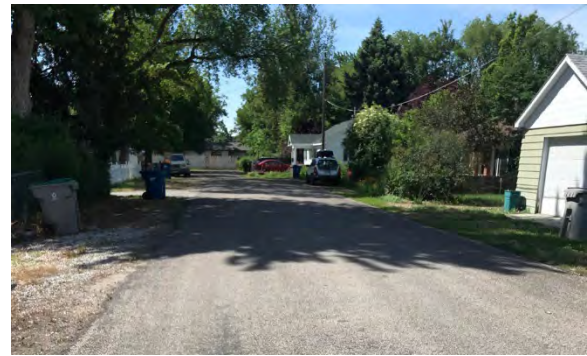
Lack of pedestrian infrastructure along both sides of West Palouse Street

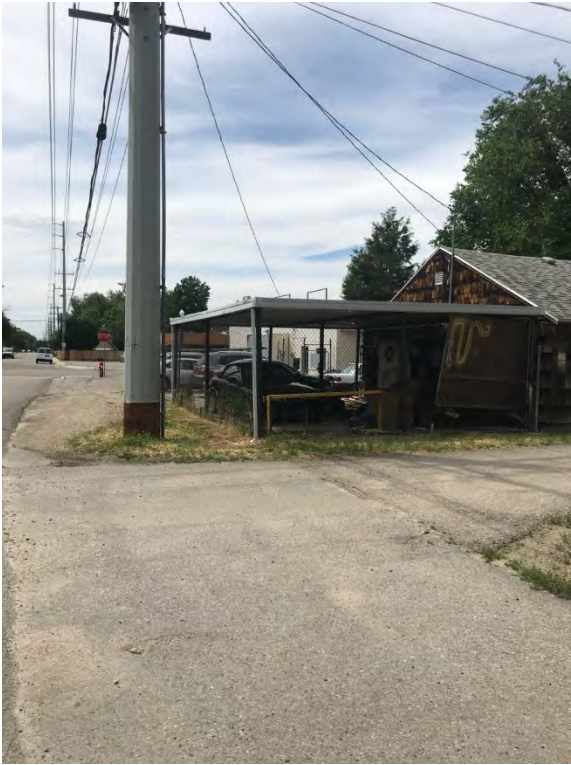
Lack of pedestrian infrastructure along South Vista Avenue

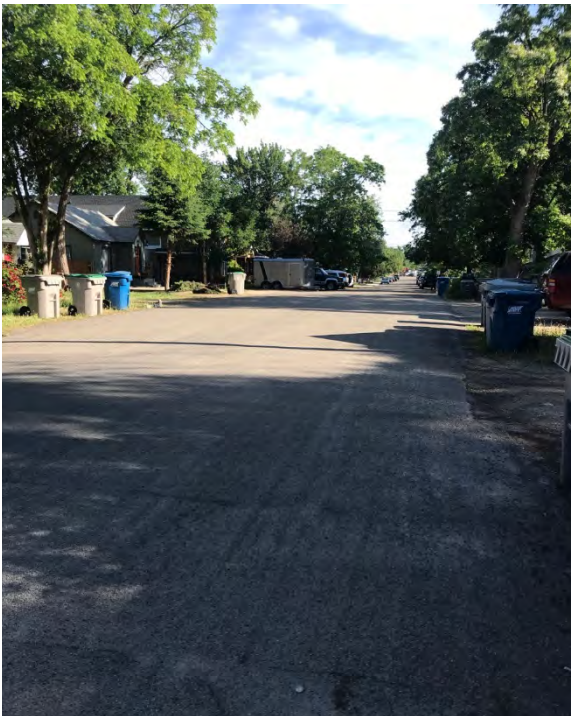
View along South Broxon Street showing lack of pedestrian infrastructure and drainage along both sides of the street.

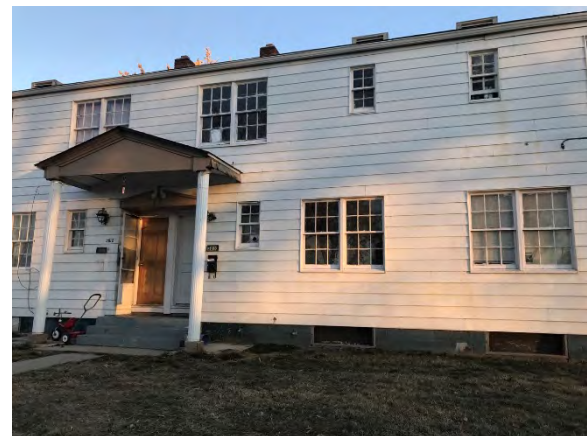
Frame multi-family building on West Pershing constructed in 1941 showing evidence of deterioration and not in conformance with current fire code, posing a safety risk to residents.

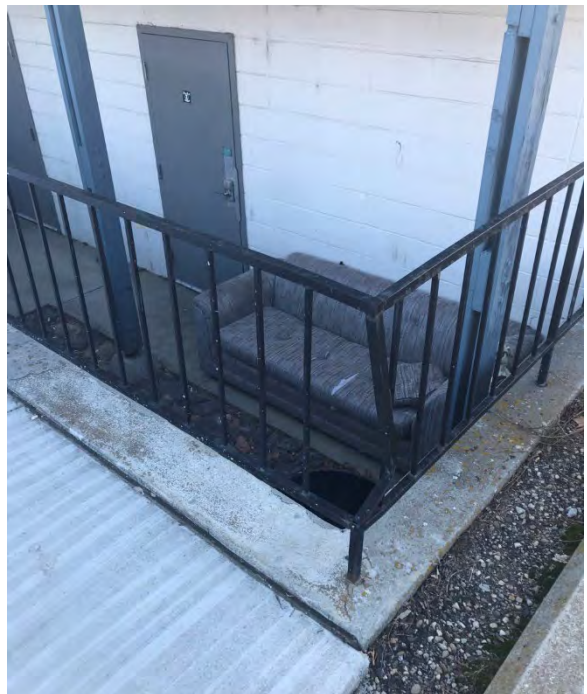
Commercial building on South Latah Street dating from 1967 that shows signs of deterioration, obsolescence, and lack of economic productivity due to high vacancy and inefficient use of the site.

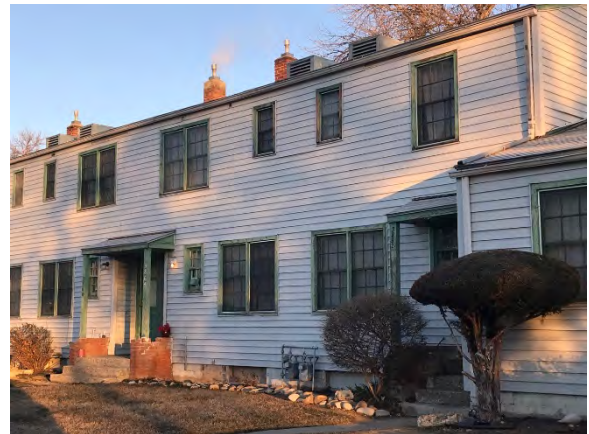
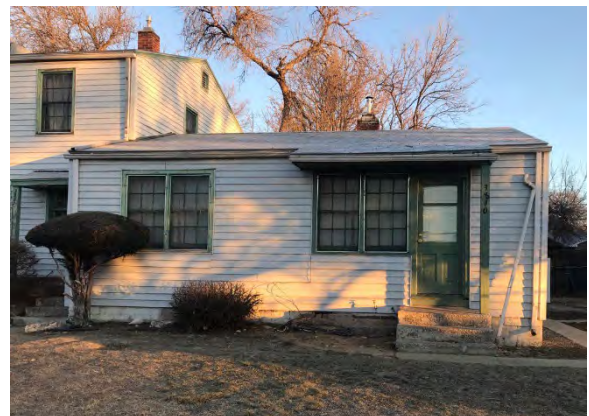
1940s frame apartment building on West Pershing. Apartment buildings are now required to have fire sprinklers, so older apartments like this building would be considered obsolete.

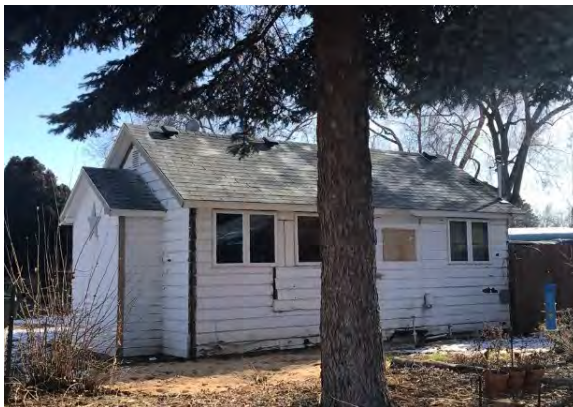
This small frame house built in 1945 is showing signs of deterioration. The 3600 and 3700 blocks of Vaughn, including this parcel, lack sidewalks.

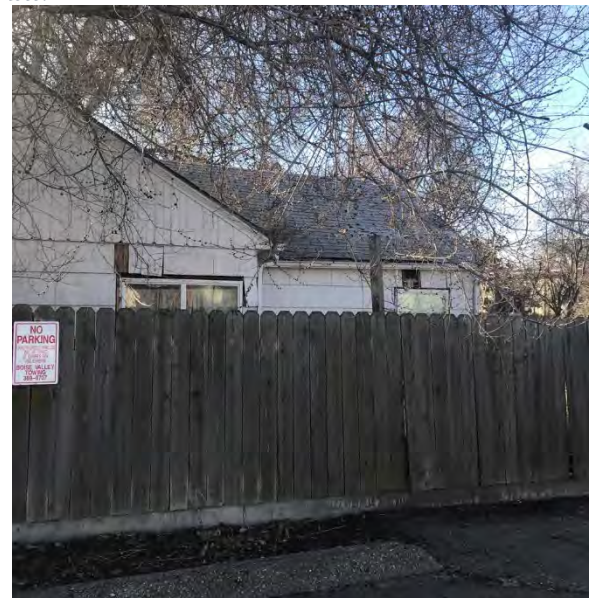
Deteriorated single family home on South Latah Street with missing shingles.

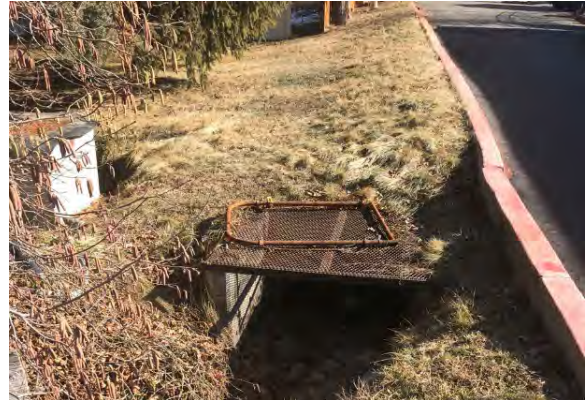
Drainage infrastructure adjacent to North Latah Street does not adequately prevent falls, injury, or entry.

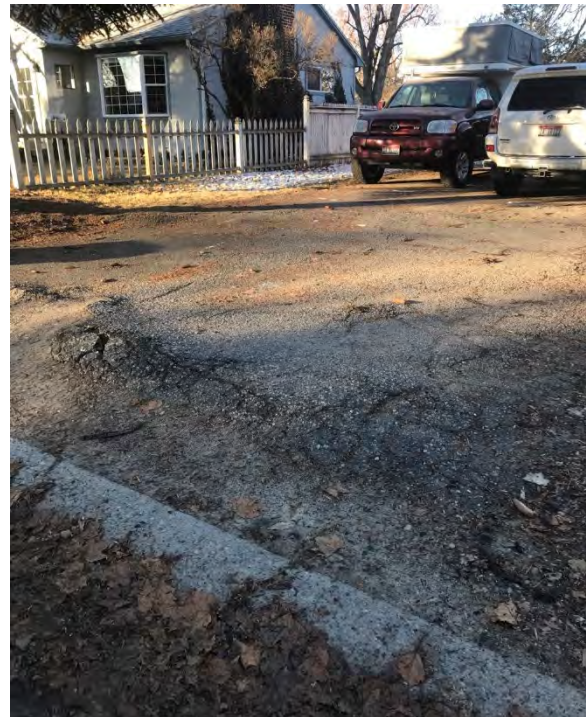
Buckling driveway along South Berkeley Street

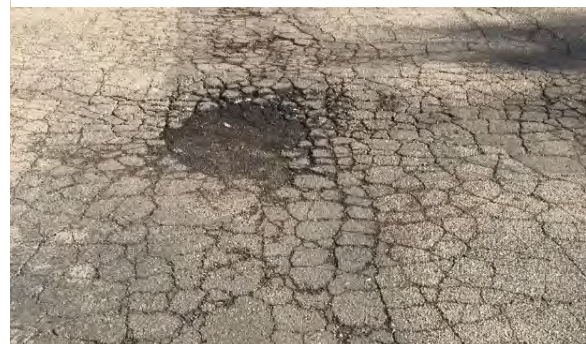
Deteriorated and missing pavement in the parking lot of the commercial building along North Latah Street.

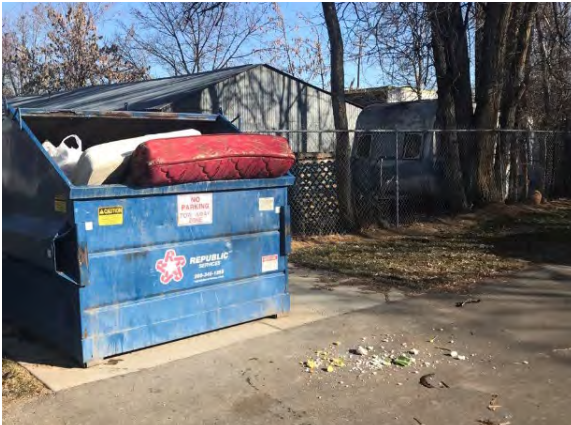
Uncovered dumpster behind 3905 West Alpine Street and food on ground, which can attract vermin.

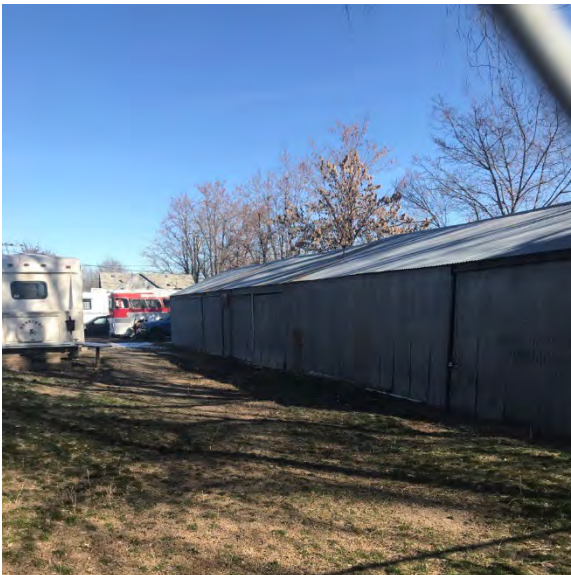
Rusting corrugated metal shed and multiple vehicle storage at rear of residential property along West Alpine Street

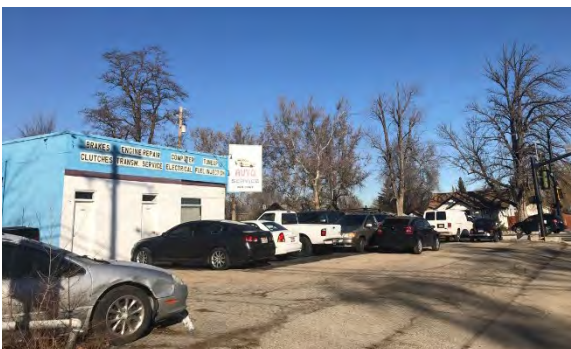
Deterioration of asphalt in parking lot along West Rose Hill Street.

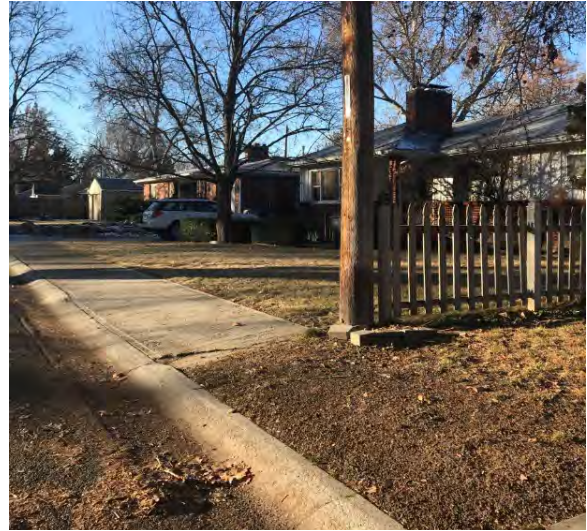
Sidewalk ending abruptly on South Berkeley Street. Lack of sidewalks on secondary streets are a pedestrian safety concern throughout the Latah subarea.

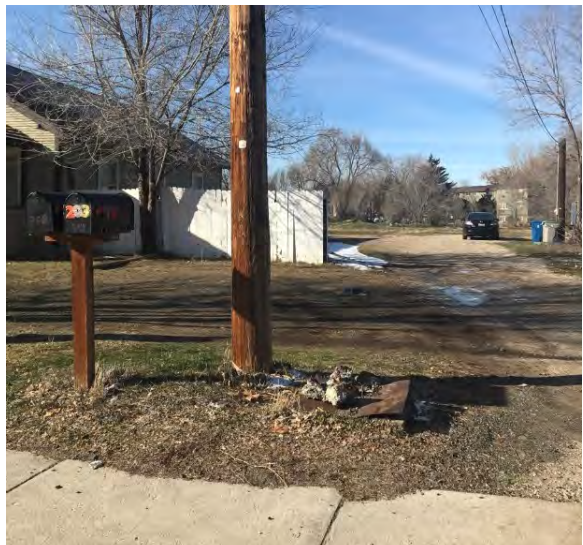
Driveway on South Latah Street providing access to interior parcels that have no formal access to the roadway network.

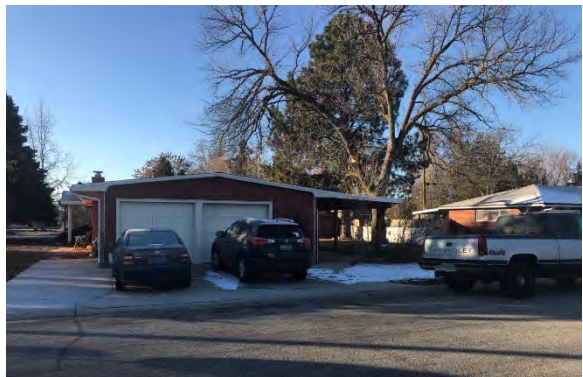
Lack of sidewalks on South Latah Street

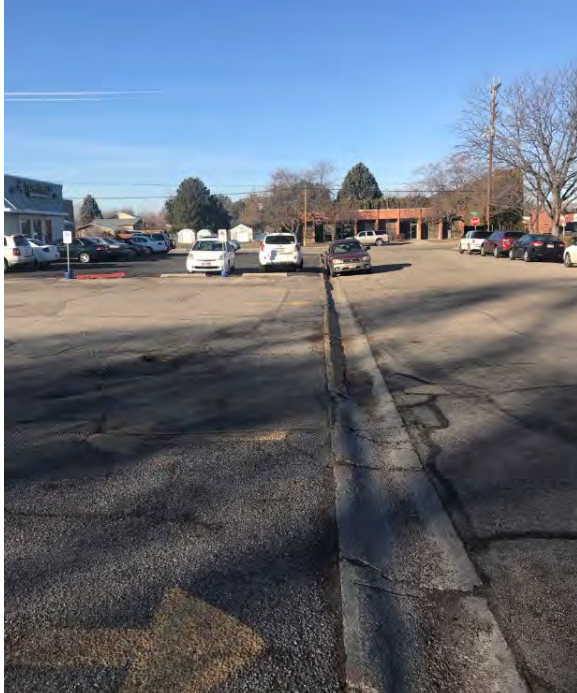
Parking lot on La Cassia Drive, a small commercial building dating from 1963, showing lack of pedestrian infrastructure, deteriorated roadway conditions, and poorly-designed site access.

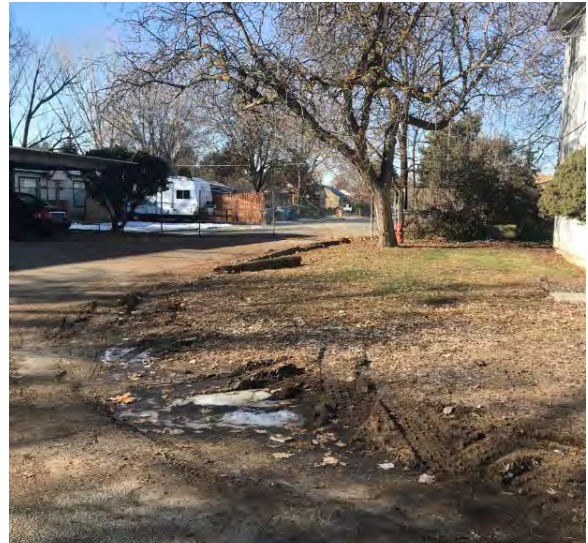
Multi-family housing on South Stapleton Lane. Showing lack of through access (fence at rear of parcel), which is a concern in the subarea. Emergency vehicle access is hindered because of limited entry points and inability to turn around. Site deterioration is also visible in the foreground.

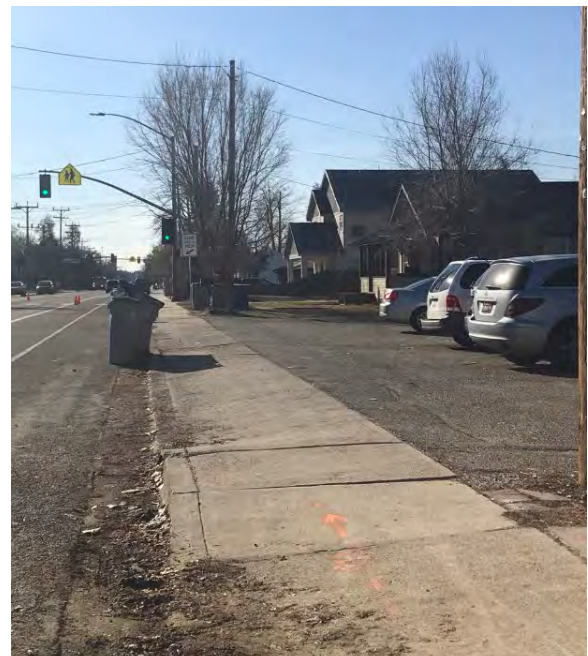
South Latah Street. This photo shows access to and parking for an eight-bedroom single-family home outside of the photo to the right. The wide driveways and pull-in/pull-out parking configuration creates a hazard to pedestrians and bicyclists and the lack of permeable surface increases the burden on stormwater infrastructure.
